Roof Coating with Belzona 3111

ID: 10135

Application: RPA-Roof Problem Areas

Substrate: Concrete

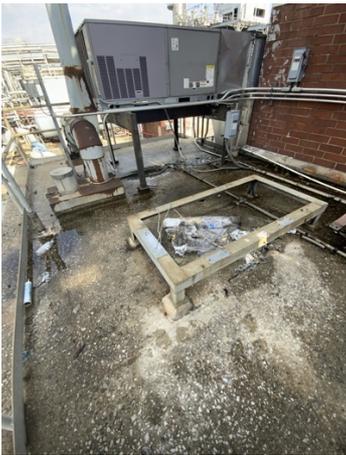
You can see in this photo the water standing due to poor slope and deep pitting in the concrete caused from deterioration.

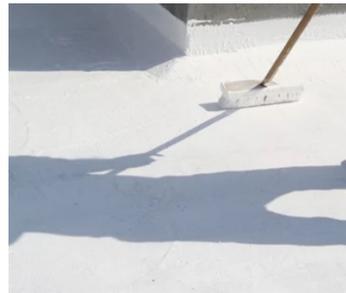
After pressure washing the roof we applied Belzona 3911 Conditioner.

Next we applied four coats of Belzona 3111 to help fill the pitting and create a complete seal.

For this application we used a steam pressure washer to remove all dirt and debris from the roof. Then we applied Belzona 3911 and 3111 using 1/2 inch nap rollers to ensure the coating penetrated the pitting areas in the surface.

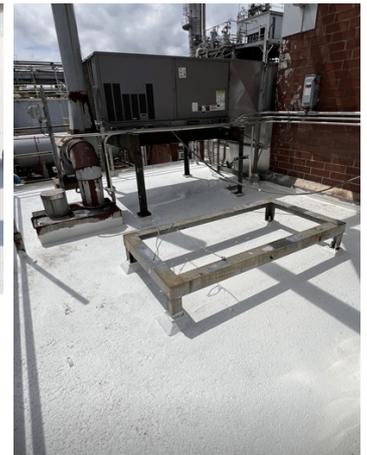
Completed roof coating project using Belzona 3911 and 3111.
