Roof Coating with Belzona 3111

ID: 10135

Application: RPA-Roof Problem Areas

Substrate: Concrete

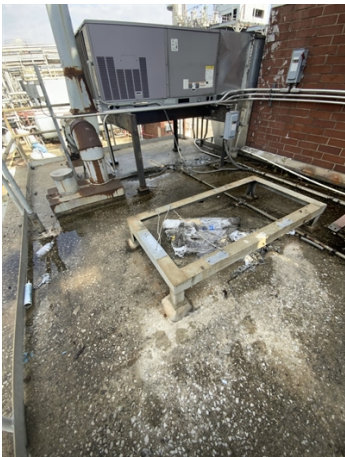
You can see in this photo the water standing due to poor slope and deep pitting in the concrete caused from deterioration.

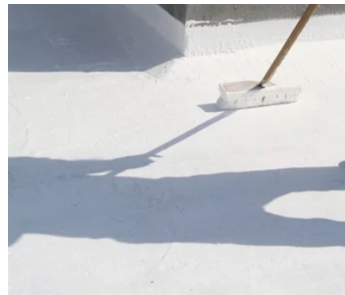
After pressure washing the roof we applied Belzona 3911 Conditioner.

For this application we used a steam pressure washer to remove all dirt and debris from the roof. Then we applied Belzona 3911 and 3111 using 1/2 inch nap rollers to ensure the coating penetrated the pitting areas in the surface.

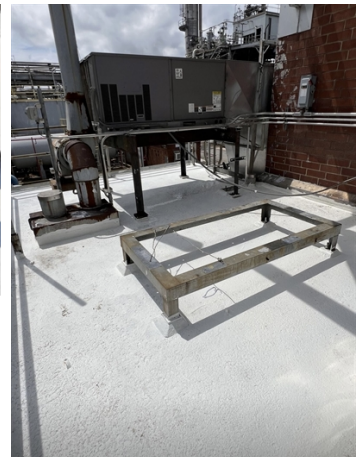
Next we applied four coats of Belzona 3111 to help fill the pitting and create a complete seal.

Completed roof coating project using Belzona 3911 and 3111.
