Belzona Restores a Cone Shaped Cyclone Separator

ID: 10137

Industry: Chemical & Petrochemical

Products: Belzona 1311 (Ceramic R-Metal), Belzona 1381, Accessories

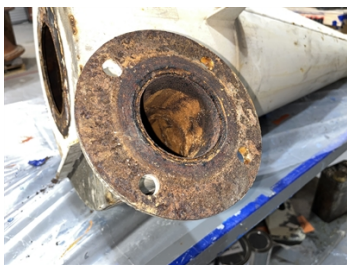
The customer had a cyclone separator that constantly vibrates to separate solids inside. The process over time eroded the metal and created through wall defects. The cost & time for a replacement was not feasible. Weld repair was not possible because the asset had thin metal and a unique geometry. The customer was looking for a cost effective solution that allowed a quick return to service.

Before image of a flange and externals

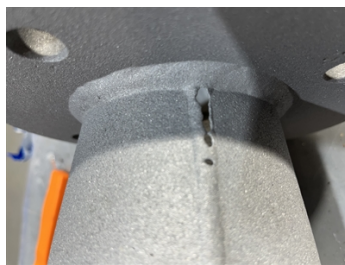
Pin holes found after blasting

1. The asset was sent to our shop for work to be done over a weekend.
2. The asset was abrasive blasted to SSPC-SP10 standard and wiped clean with Belzona 9111 degreaser.
3. Belzona 1311 paste was applied to plate bond over any through wall defects, pit fill, and smooth welds as needed.
4. Belzona 1311 was applied by hand to rebuild the flange faces to create a flat surface. After dimensionally stable, the 1311 was sanded flush best effort.
5. Belzona 1381 was applied in a two coat system to the internals of the asset.
6. Belzona 1381 was applied with 9341 mesh to composite wrap the bottom 24" externally, and the top nozzle.
7. Visual inspection and touch ups completed. Product was allowed to cure, and returned to customer.

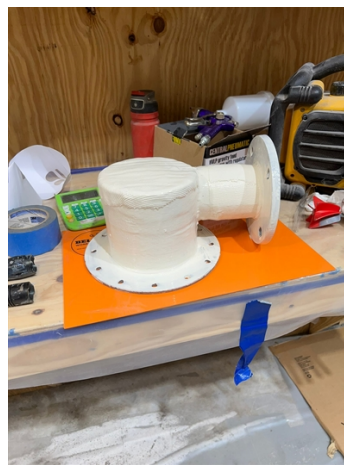
External repair completed on the top nozzle piece

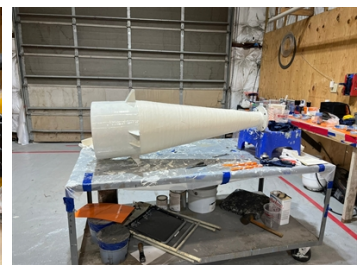
External repair completed on the main body of the separator
