Cooling Tower Pipe Coating

ID: 10139

Industry: Steel & Metal Processing
Application: VPF-Valves, Pipes and Fittings
Substrate: Carbon steel
Products: Belzona 5831 (ST-Barrier)

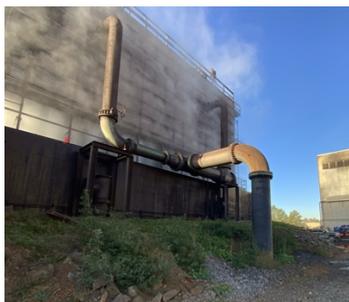
The client was facing deterioration on their exterior piping to the cooling tower from years of exposure to the elements without a coating.

Exterior cooling tower piping before any prep or Belzona coating.

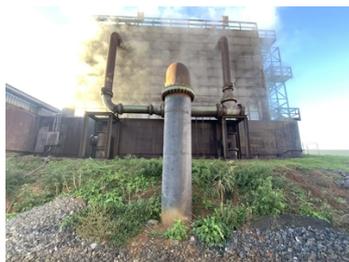
Photo after pressure washing only.

We used a normal pressure washer to surface prep the pipe followed by a wire wheel to remove heavier rust in some areas. Next we cleaned the pipe using 100% MEK. Then we applied the Belzona 5831 using half inch nap rollers to ensure the coating was applied throughly and absorbed in the deeper pitted areas.

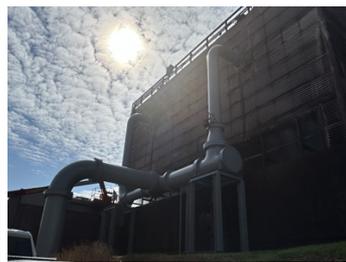
After applying Belzona 5831

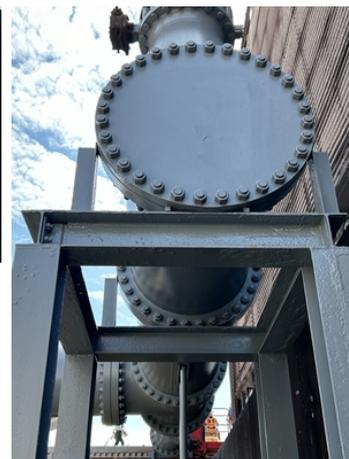
Close up of Belzona 5831
