Belzona solution for damaged fly ash elbow.

ID: 10143

Industry: Power
Application: VPF-Valves, Pipes and Fittings
Substrate: Carbon steel
Products: Belzona 1813, Belzona 1983 (SuperWrap II)

Customer Location: NW Arkansas
Application Date: December 2025

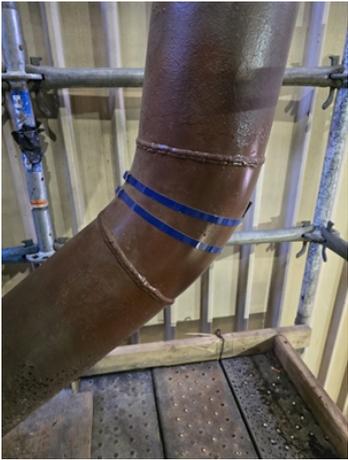
This elbow was replaced only a few months prior and had already developed a hole on the outside of the elbow.

Fly ash elbow with temporary patch.

The elbow was only a couple months old and had developed a hole from the fly ash falling through it. Replacing the elbow would have involved a shutdown and cutting the pipe and welding a new one in place. Should the new elbow fail in the same timeframe, this shutdown and replace option would have to happen several times per year, and there are four of these elbows in this process.

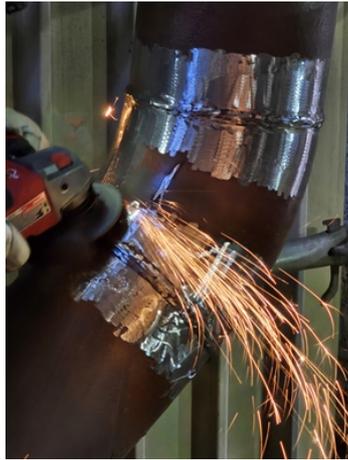
Removing the paint and prepping the surface.

Due to location, hand tool prep was the only allowable option. A grinder was used to remove the paint and to roughen the application area. The area was then washed with solvent, and Belzona 1813 was applied to the elbow in an area greater than the worn hole to address future wear as well. Once the Belzona 1813 had reached its overcoat window (based on the IFU), three layers of Belzona SuperWrap II were applied using Belzona 1983 resin and Belzona 9381 carbon fiber. The application was completed with the Belzona 9382 condensing wrap and allowed to cure. Belzona 1813 and Belzona 1983 resins were chosen due to the elevated operating temperature

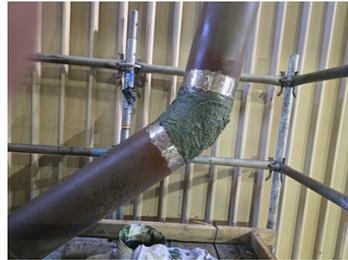
Belzona 1813 applied to the elbow.

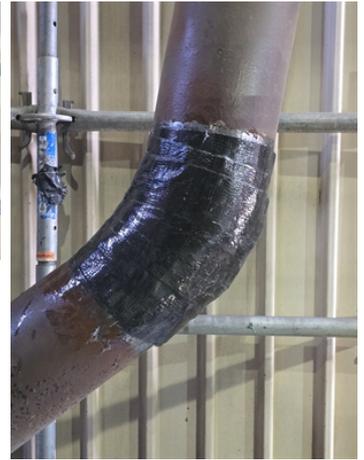
Belzona SuperWrap II applied over the Belzona 1813 and the elbow.
