Belzona solution for damaged fly ash elbow.

ID: 10143

Industry: Power
Application: VPF-Valves, Pipes and Fittings
Substrate: Carbon steel
Products: Belzona 1813, Belzona 1983 (SuperWrap II)

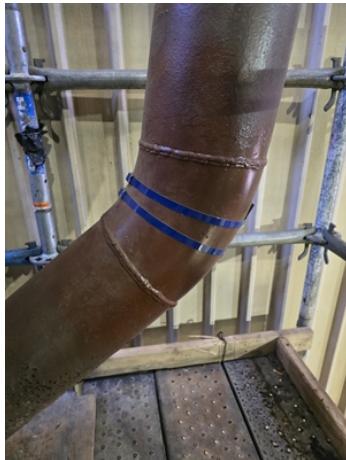
This elbow was replaced only a few months prior and had already developed a hole on the outside of the elbow.

Fly ash elbow with temporary patch.

The elbow was only a couple months old and had developed a hole from the fly ash falling through it. Replacing the elbow would have involved a shutdown and cutting the pipe and welding a new one in place. Should the new elbow fail in the same timeframe, this shutdown and replace option would have to happen several times per year, and there are four of these elbows in this process.

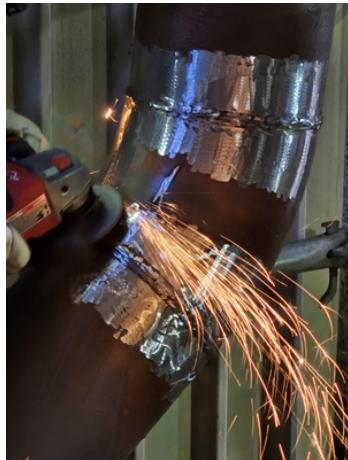
Removing the paint and prepping the surface.

Due to location, hand tool prep was the only allowable option. A grinder was used to remove the paint and to roughen the application area. The area was then washed with solvent, and Belzona 1813 was applied to the elbow in an area greater than the worn hole to address future wear as well. Once the Belzona 1813 had reached its overcoat window (based on the IFU), three layers of Belzona SuperWrap II were applied using Belzona 1983 resin and Belzona 9381 carbon fiber. The application was completed with the Belzona 9382 condensing wrap and allowed to cure. Belzona 1813 and Belzona 1983 resins were chosen due to the elevated operating temperature

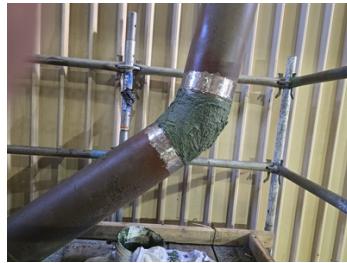
Belzona 1813 applied to the elbow.

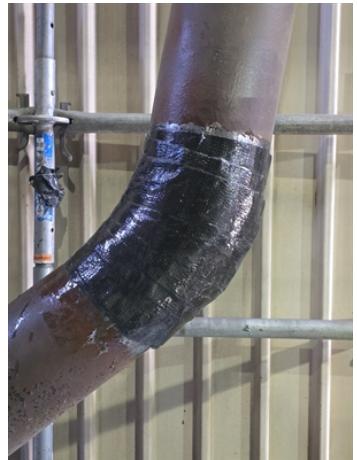
Belzona SuperWrap II applied over the Belzona 1813 and the elbow.
