Secondary Containment Coating using Belzona 4311

ID: 10145

Industry:	Steel & Metal Processing	Customer Location:	Muscle Shoals, AL
Application:	TCC-Tanks and Chemical Containment Areas	Application Date:	February 2024
Substrate:	Concrete		
Products:	Belzona 4111 (Magma-Quartz),Belzona 4311 (Magma CR1),Belzona 4911 (Magma TX Conditioner)

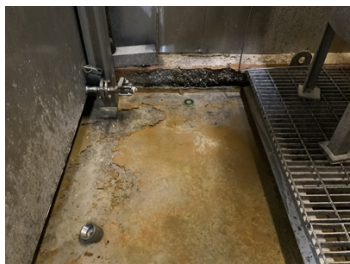
The client was facing major deterioration of their concrete due to the chemicals in the process and the coating not properly maintained over the years. This allowed for the chemicals and liquids to penetrate under the coating causing it to delaminate.

You can see in this photo how the chemicals had broken down the other coating overtime.

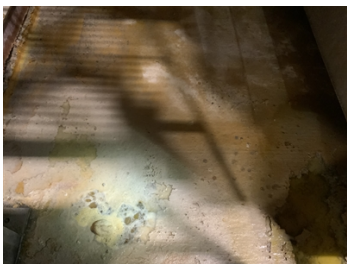
A close up view of the old coating and how it is delaminating.

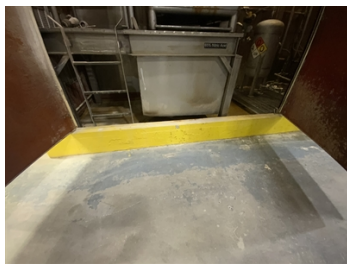
This photo shows you how we cleaned and removed the old coating and prepped the surface area to be coated.

We used normal procedures provided by Belzona for the application process. Floor grinders and needle guns were used to remove delaminated concrete.

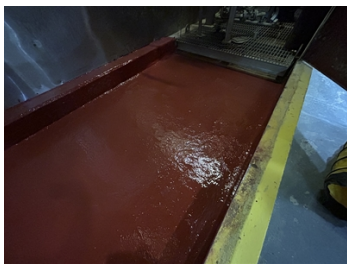
Final photo shows the completed project using Belzona 4111 and Belzona 4311.
