# Secondary Containment Coating using Belzona 4311

ID: 10145

**Industry:** Steel & Metal Processing  
**Application:** TCC-Tanks and Chemical Containment Areas  
**Substrate:** Concrete  
**Products:** Belzona 4111 (Magma-Quartz), Belzona 4311 (Magma CR1), Belzona 4911 (Magma TX Conditioner)

**Customer Location:** Muscle Shoals, AL  
**Application Date:** February 2024

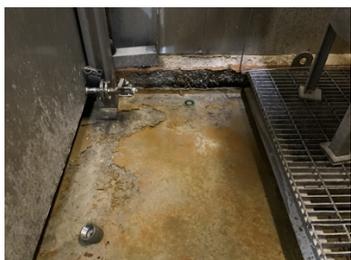
You can see in this photo how the chemicals had broken down the other coating overtime.

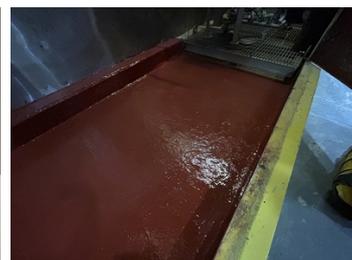
Final photo shows the completed project using Belzona 4111 and Belzona 4311.

We used normal procedures provided by Belzona for the application process. Floor grinders and needle guns were used to remove delaminated concrete.
