# Saved spool piece with Belzona

ID: 10146

Industry: Power  
Application: VPF-Valves, Pipes and Fittings  
Substrate: Carbon steel  
Products: Belzona 1321 (Ceramic S-Metal)

Customer Location: Decatur, AL  
Application Date: March 2025

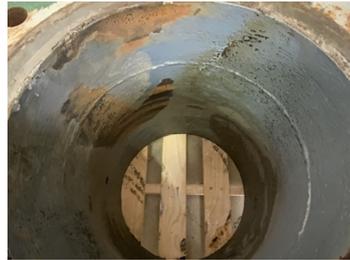
Before picture of the spool piece.

You can see the old coating had started to wear off.

For this application we first blasted the surface to a 3 mil profile followed by cleaning with 100% MEK. Next we applied two coats of Belzona 1321 using a stiff bristle brush.

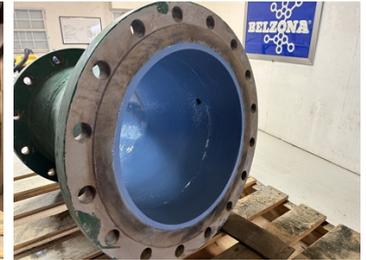
After blasting to a 3 mil profile and first coat of Belzona 1321
