Saved spool piece with Belzona

ID: 10146

Industry: Power
Application: VPF-Valves, Pipes and Fittings
Substrate: Carbon steel
Products: Belzona 1321 (Ceramic S-Metal)

Customer Location: Decatur, AL
Application Date: March 2025

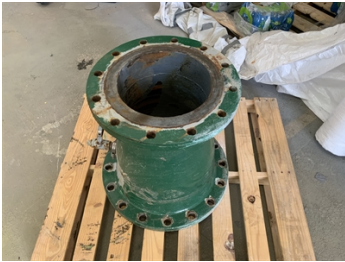
Before picture of the spool piece.

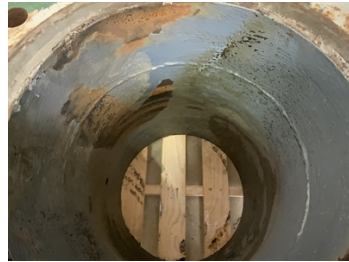
You can see the old coating had started to wear off.

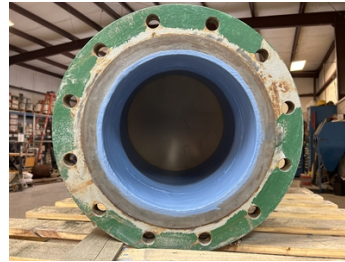
After blasting to a 3 mil profile and first coat of Belzona 1321

For this application we first blasted the surface to a 3 mil profile followed by cleaning with 100% MEK. Next we applied two coats of Belzona 1321 using a stiff bristle brush.

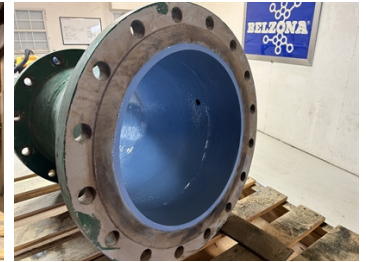
Completed photo of spool piece with two coats of Belzona 1321
