RotoClone Wet Dust Collector - External Plate Bond Repair

ID: 10148

Industry: Chemical & Petrochemical
Application: FBC-Fans, Blowers and Compressors

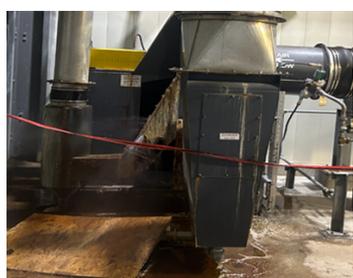
Asset in service, with moisture coming out of the defects. Area has red tape to prevent access. Moisture spilling on the floor.

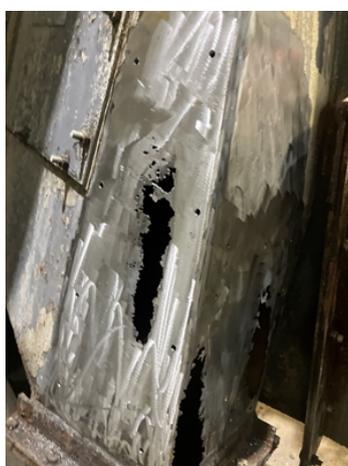
Surface prep complete with power tools.

1. Asset taken out of service and allowed to dry.
2. A grinder with a tiger pad was used to prep the metal surface.
3. Three metal plates were fabricated and pre cut to the size needed to fit over the defect areas.
4. Belzona 1111 was mixed and applied to the asset and back of each plate. Each plate was laid in place and self tapping screws were applied to help compress the plates in place. Additional Belzona 1111 was used to chamfer the edges of the plate best effort, and to putty over the screws.
5. Belzona 1111 was force cured using heat blankets, per the IFU. About 2 hours at ambient then about 4 hours between 140F-200F, ramping up in 50F increments from ambient.

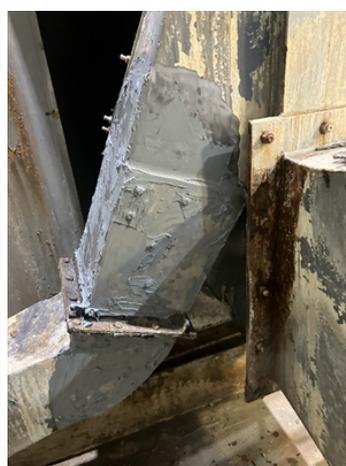
Plate bond application.

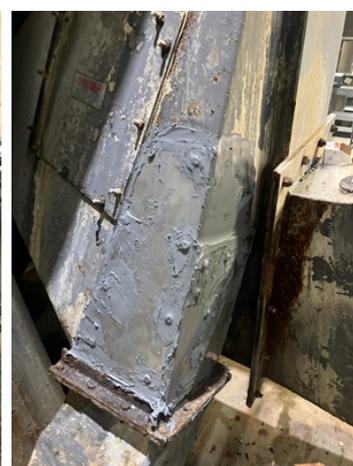
Plate bond application.
