# RotoClone Wet Dust Collector - External Plate Bond Repair

ID: 10148

Industry: Chemical & Petrochemical  
Application: FBC-Fans, Blowers and Compressors

Substrate: Carbon steel  
Products: Belzona 1111 (Super Metal)

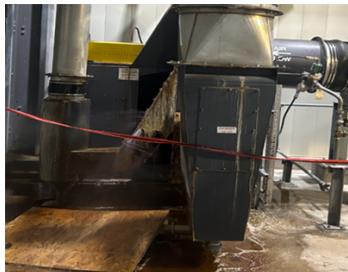
Asset in service, with moisture coming out of the defects. Area has red tape to prevent access. Moisture spilling on the floor.

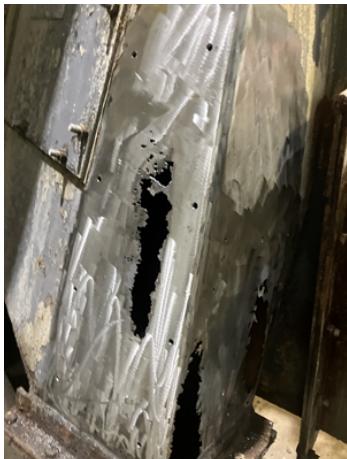
Surface prep complete with power tools.

1. Asset taken out of service and allowed to dry.
2. A grinder with a tiger pad was used to prep the metal surface.
3. Three metal plates were fabricated and pre cut to the size needed to fit over the defect areas.
4. Belzona 1111 was mixed and applied to the asset and back of each plate. Each plate was laid in place and self tapping screws were applied to help compress the plates in place. Additional Belzona 1111 was used to chamfer the edges of the plate best effort, and to putty over the screws.
5. Belzona 1111 was force cured using heat blankets, per the IFU. About 2 hours at ambient then about 4 hours between 140F-200F, ramping up in 50F increments from ambient.

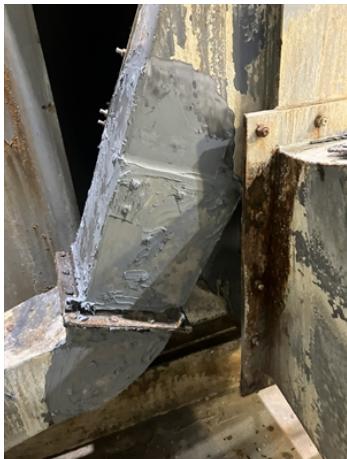
Plate bond application.

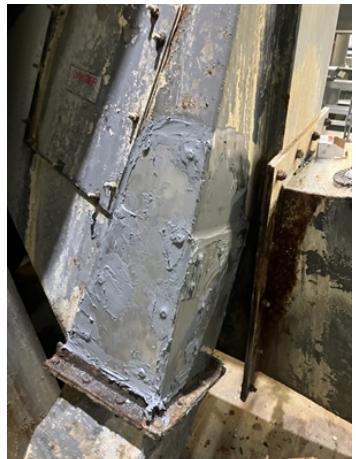
Plate bond application.
