Brass Impeller repair and coating

ID: 10149

Industry: *Marine*
Application: *PDP-Positive Displacement Pumps*

Substrate: *Bronze*
Products: *Belzona 1111 (Super Metal), Belzona 1321 (Ceramic S-Metal)*

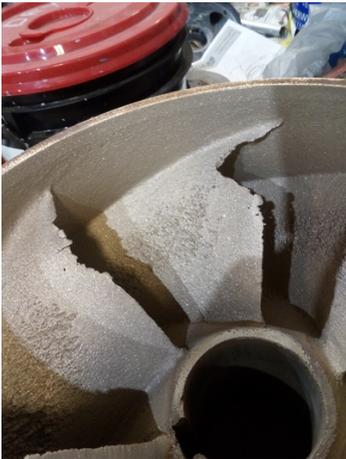
The client took a pump out of service for inspection and found several problem areas. The impeller being one of them. The leading edges were worn almost half way off.

Notice leading edge of impeller blades

We began by blasting to a 3 mil profile then cleaning the surface with 100% MEK. Followed by our crafty applicator repairing the leading edges with Belzona 1111. We completed the application with two coats of Belzona 1321.

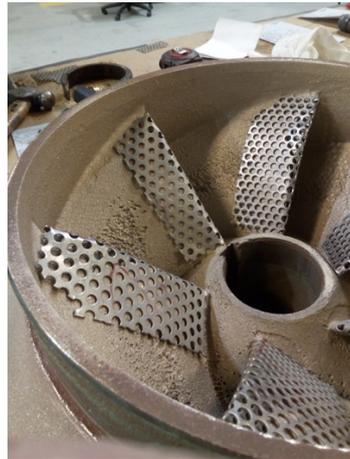
Giving this impeller back its leading edges

After Belzona 1111 metal repair

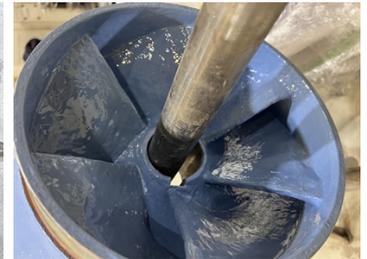
After two coats of Belzona 1321
