Mop Sink Waterproofing and Leak Prevention Using Belzona 3121

ID: 10150

Application: FPA-Floor Problem Areas

Products: Belzona 3121 (MR7)

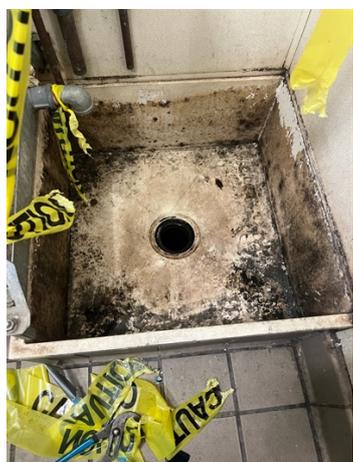
Mop sink showing water infiltration points around the drain and wall interfaces prior to repair. Gaps between the sink, walls, and drain allowed water to escape the basin and leak to lower floors.

The area around the mop sink was thoroughly cleaned and dried to remove dirt, residue, and contaminants. The joint between the sink and the wall, as well as the drain outlet area, was prepared to ensure proper adhesion.

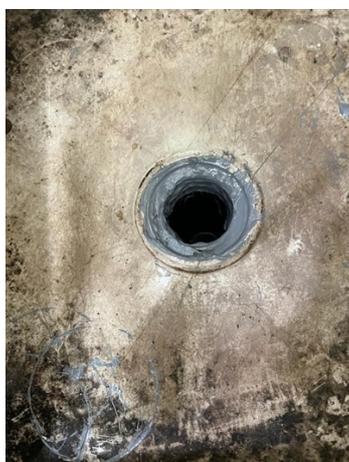
Close-up of the drain penetration sealed using Belzona 3121 (MR7) to prevent water migration around the pipe connection.

Belzona 3121 (MR7) was applied directly to the gap between the mop sink and the wall to create a continuous waterproof seal. Belzona 9331 reinforcing sheet was embedded into the first layer where required, followed by a second coat of Belzona 3121 to fully encapsulate the joint. The drain outlet was also reinforced to prevent future leakage. The system was allowed to cure, forming a seamless, flexible, and watertight barrier.

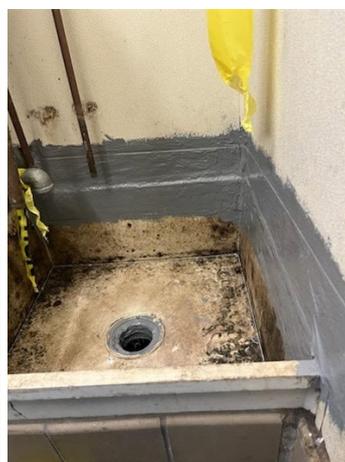
Completed repair using Belzona 3121 (MR7), creating a continuous waterproof seal directing water into the drain and preventing further leakage.
