Repair of a Deformed and Leaking 36 Inch Crude Oil Pipeline Using

ID: 10151

Industry: Oil & Gas
Application: VPF-Valves, Pipes and Fittings
Substrate: Carbon steel
Products: Belzona 1161 (Super UW-Metal), Belzona 1221 (Super E-Metal), Belzona 5831 (ST-Barrier), Belzona 9611 (ES-Metal)

Customer Location: Al Khafji, Saudi Arabia
Application Date: November 2025

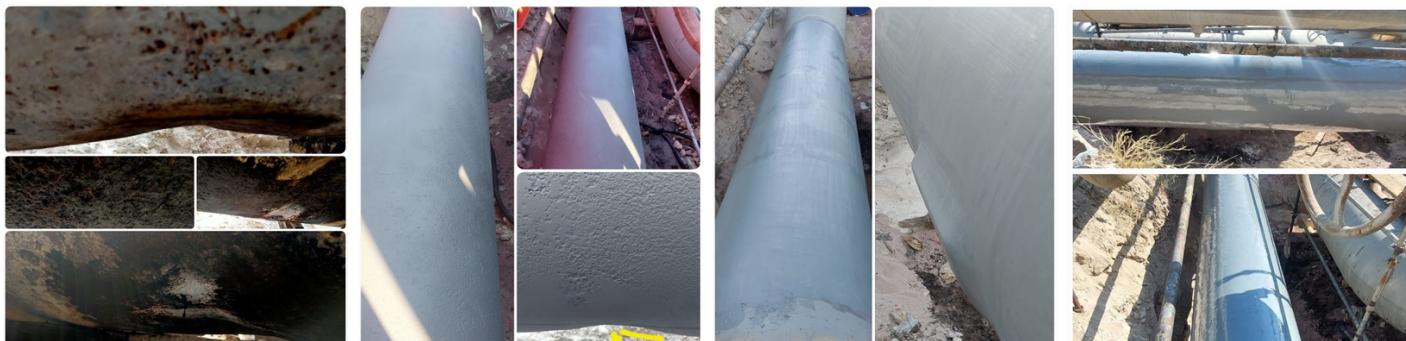
Severe external corrosion, combined with continuous loading from the support structure, caused structural deformation and the formation of a pinhole leak in a 36 inch crude oil pipeline operating at ambient temperature and 4 bar pressure.

Approximately 5 meters of the pipeline experienced significant wall-thickness loss, posing a high risk to operational safety and continuity.

Pipeline damage caused by severe external corrosion

Pipeline condition after surface preparation by grit blasting

Pipeline condition following plate bonding using Belzona 1221 and wrapping with Belzona 1161 (Super UW-Metal) and Belzona 9341

Pipeline condition following application of Belzona 5831 (ST-Barrier) for external corrosion protection

The pipeline was first shut down, and all oil residues were thoroughly cleaned from the external surface. The pinhole area was sealed using Belzona 9611 (ES-Metal) and Belzona 1221 (Super E-Metal) to prevent oil sludge flow under high ambient temperatures (35°C).

After inspection and confirmation that the Lower Explosive Limit (LEL) level was zero, abrasive blasting was carried out to achieve a minimum surface profile of 75 microns and Sa 2.5 cleanliness. A steel plate was then blasted and bonded to the 36" pipeline using Belzona 1221 to correct the deformation and restore structural integrity.

To provide long-term reinforcement, a two-wrap composite system using Belzona 1161 (Super UW-Metal) and Belzona 9341 (Lagseal Reinforcing Sheet) was applied along the affected section of the pipeline. Finally, Belzona 5831 (ST-Barrier) was applied as a topcoat to protect against future external corrosion.
