Ceramic Tile combined with Super Wrap II

ID: 10152

Application: VPF-Valves, Pipes and Fittings

Substrate: Carbon steel

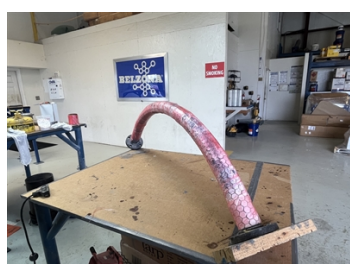
After applying ceramic tile and pre-fitting for Super Wrap II.

We began by blasting the pipe to a 3 mil profile and cleaned the surface using 100% MEK. Next we pre-fit our tile and cut to fit. Then we used Belzona 5821 with Cabosil to apply the tile, working it into the surface of the pipe and on to the back of the tile. After applying the tile we then used more Belzona 5821 with Cabosil to fill in the grout lines and coat the surface of the tile. After proper cure time we then pre-fit the Super Wrap II and applied two wraps using Belzona 1984. To complete the application we applied the consolidation tape and let cure the proper time. We have set up an inspection period with the client for every six months.

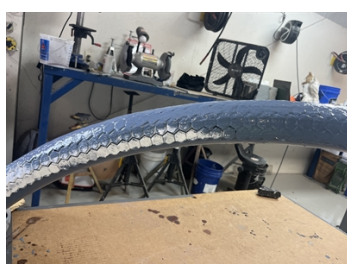
Applying 5821 with Cabosil to fill in as a grout and add some wear resistance.

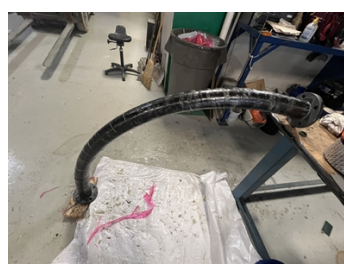
Applied Super Wrap II using Belzona 1984

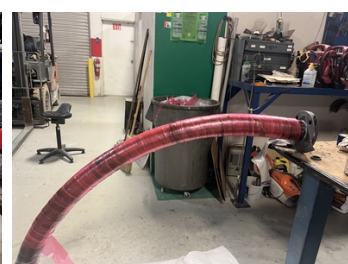
Completed wrap after applying the consolidation tape.
