# Radiator End Cap Refurbishment

ID: 10153

Industry: Power  
Application: HEX-Heat Exchangers  
Substrate: Carbon steel  
Products: Belzona 5811DW (DW Immersion Grade)

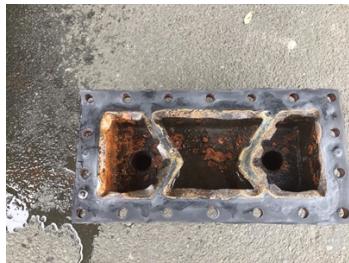
This section shows the original condition of the end caps prior to refurbishment.

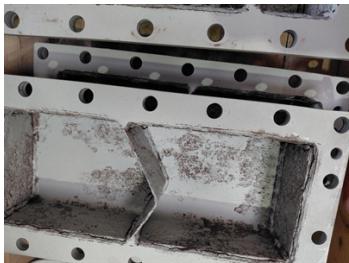
The surfaces were grit blasted to SSPC-SP10 or ISO Sa 2.5 in accordance with ISO 8501-1.

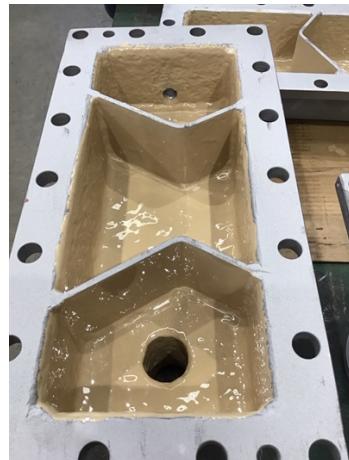
The surfaces were coated with two coats of Belzona 5811DW (DW Immersion Grade).

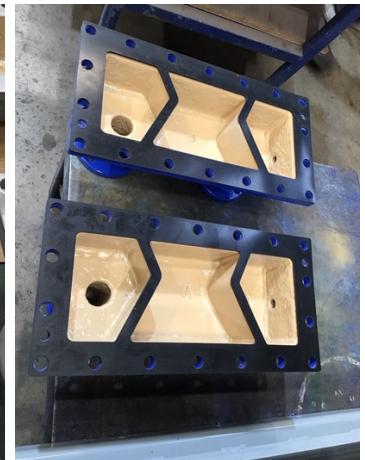
The end caps were fully reassembled with washers and are ready to be returned to service.
