Crude Oil Pipeline Repair with Belzona Conventional Wrapping

ID: 10154

Customer Location: Saudi Arabia
Application Date: June 2021

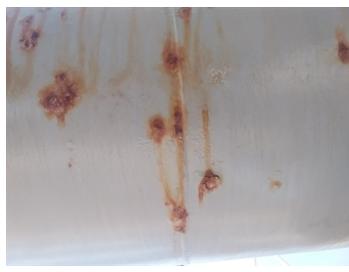
The customer was experiencing issues with a crude oil transfer pipeline located in the power plant's marine jetty area. The pipeline had developed pinholes and exhibited reduced wall thickness, posing a risk of leakage and potential operational hazards.

Overview of Pinholes and External Corrosion on the Pipeline

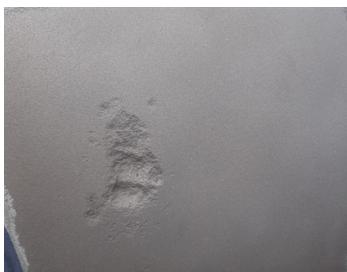
Condition After Grit Blasting
Surface Preparation

1. The surface was prepared by grit blasting.
2. Belzona 9111 (Cleaner/Degreaser) was used to remove all remaining contaminants.

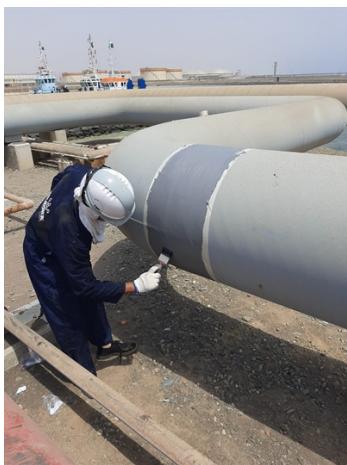
Application of Belzona 1111 (Super Metal) and Belzona 9341 (Reinforcement Tape) conventional wrapping in progress.

3. Belzona 1111 (Super Metal) was applied in conjunction with Belzona 9341 (Reinforcement Tape).

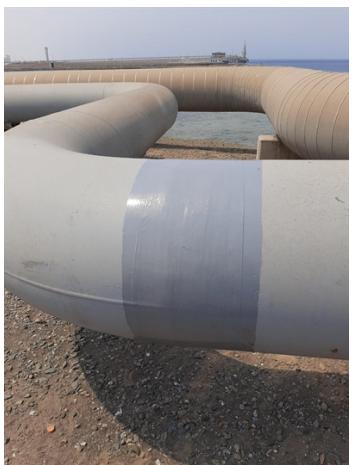
Completed application of the Belzona conventional wrapping system.

4. The system was left to cure in accordance with the manufacturer's instructions.
