Major Airport in South Florida Needs Belzona for a Smooth Access

ID: 10156

Customer Location: South Florida
Application Date: November 2014

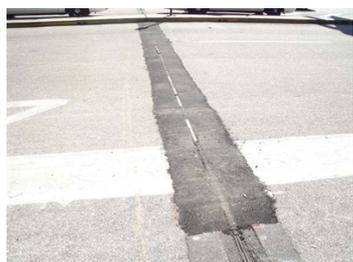
The failing expansion joints of the upper deck main access road to an international airport created serious safety concerns. The combination of the crumbling concrete joints nosings and the leaks to the lower decks required a high quality and long lasting solution.

Existing expansion joints

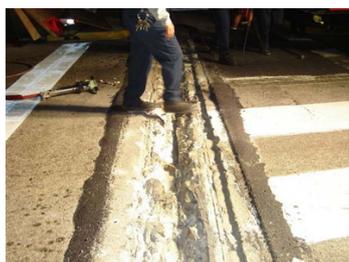
Surface preparation completed

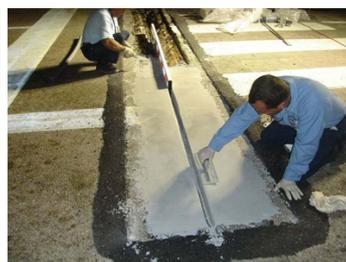
Expansion joint nosings being rebuilt with Belzona 4111

Application was carried out in accordance with Belzona Know-How System Leaflet FPA-5. Joint nosings were rebuilt with Belzona® 4111 prior to applying Belzona 2221 as new joint sealant.

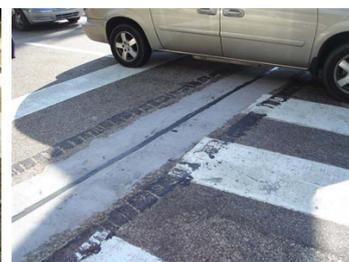
Application completed

Belzona® 4111 was used to repair the concrete due to the quick cure times and extreme compressive strength. Belzona 2221 was used due to superior adhesion and great resistance to wear and tear. Repair was in great condition until a complete overhaul a few years later.
