Major Airport in South Florida Needs Belzona for a Smooth Access

ID: 10156

Industry: *Buildings & Structures*
Application: *FPA-Floor Problem Areas*
Substrate: *Concrete*
Products: *Belzona 2221 (MP Fluid Elastomer), Belzona 2911 (Elastomer QD Conditioner), Belzona 4111 (Magma-Quartz), Belzona 4911 (Magma TX Conditioner)*

Customer Location: *South Florida*
Application Date: *November 2014*

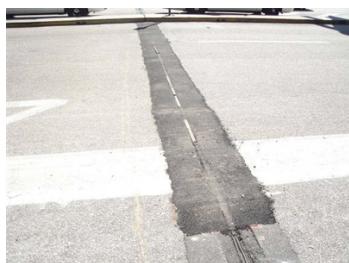
The failing expansion joints of the upper deck main access road to an international airport created serious safety concerns. The combination of the crumbling concrete joints nosings and the leaks to the lower decks required a high quality and long lasting solution.

Existing expansion joints

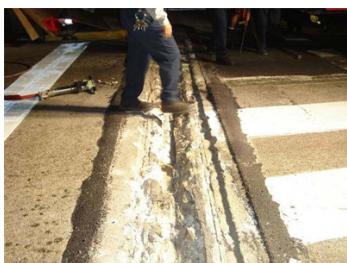
Surface preparation completed

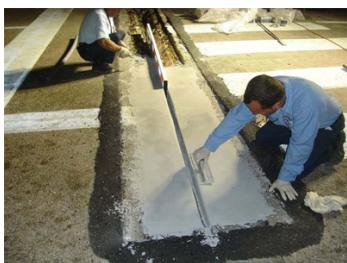
Expansion joint nosings being rebuilt with Belzona 4111

Application was carried out in accordance with Belzona Know-How System Leaflet FPA-5. Joint nosings were rebuilt with Belzona® 4111 prior to applying Belzona 2221 as new joint sealant.

Belzona® 4111 was used to repair the concrete due to the quick cure times and extreme compressive strength. Belzona 2221 was used due to superior adhesion and great resistance to wear and tear. Repair was in great condition until a complete overhaul a few years later.

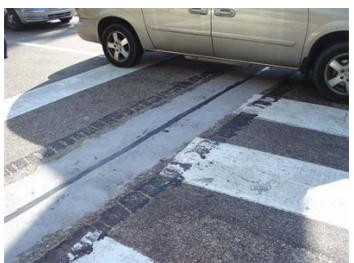
Application completed
