# Belzona Solution for Worn Pump Impeller

ID: 10162

Industry: Power  
Application: CEP-Centrifugal Pumps  
Substrate: Carbon steel  
Products: Belzona 1121 (Super XL-Metal), Belzona 1331

Customer Location: Thailand  
Application Date: January 2020

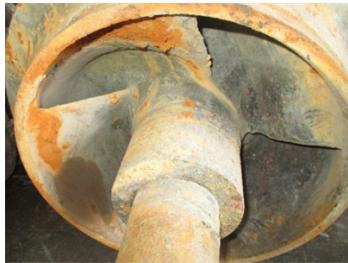
Damage surface on pump impeller caused by erosion and corrosion

Pump impeller showing damage caused by erosion and corrosion

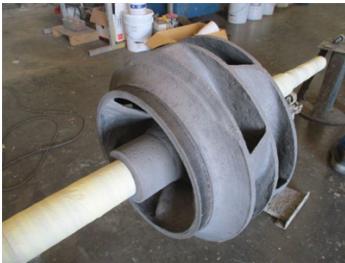
Carbon steel surface prepared by grit blasting with steel grit to give a minimum depth of 75 microns and surface cleanliness by Swedish standard Sa 2.5

1. Carbon steel surface on the impeller was prepared by blasting with steel grit to give a minimum average profile depth of 75 microns and Surface cleanliness to Swedish standard Sa 2.5
2. Clean and brush away any loose contaminant, cleaning with vacuum and then cleaning the surface with Methyl Ethyl Ketone.
3. Apply the first layer of Belzona 1331 at a dry film thickness of 200 microns
4. The pitted areas were rebuilt with Belzona 1121 (Super XL Metal)
5. Apply the second layer of Belzona 1331 at a dry film thickness of 200 microns
6. Check dry film thickness with PHYNIX DFT Tester
7. Check the pinhole with the PCWI low-voltage tester.
8. Before putting the pump part back to service, it required two days for the full cure.

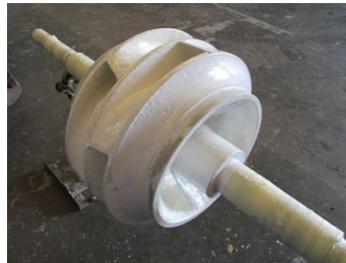
The first coat of Belzona 1331

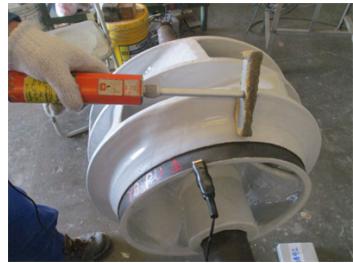
After the second coat of Belzona 1331 was fully cured, it was inspected for holidays/pinholes with a PCWI low voltage tester and successfully passed.
