# Refurbishment of Damaged Oil Strainer Using Belzona

ID: 10164

Industry: Oil & Gas  
Application: CEP-Centrifugal Pumps  
Substrate: Cast Iron  
Products: Belzona 1111 (Super Metal), Belzona 3921 (GSC Surface Conditioner), Belzona 4341 (Magma CR4), Belzona 5111 (Ceramic Cladding)

Customer Location: Al Khafji  
Application Date: January 2025

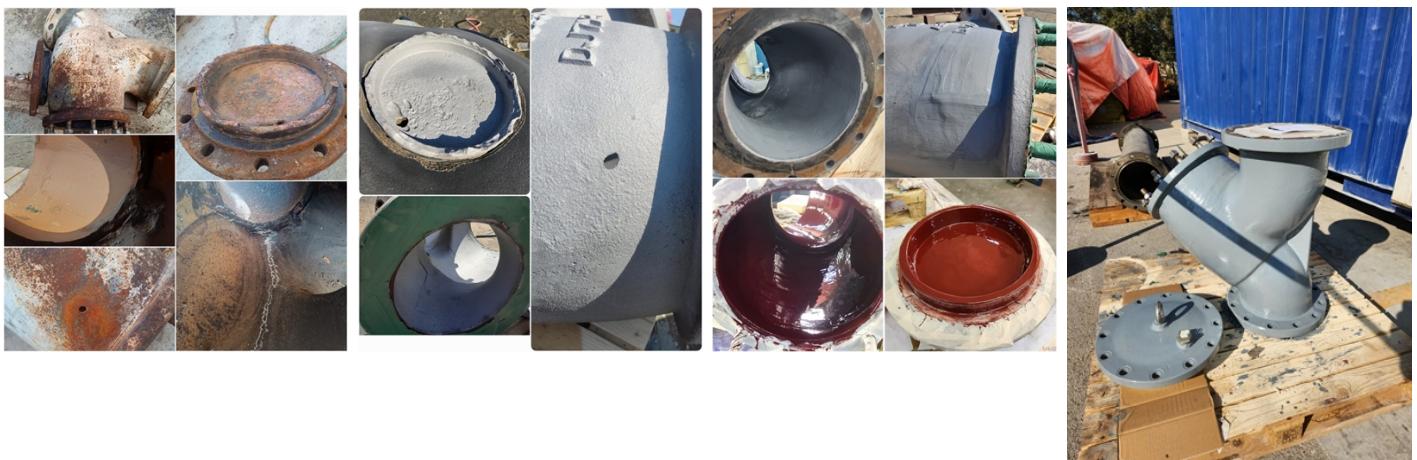
Initial condition of strainer

Surface preparation conducted via grit blasting

Application in progress using Belzona 1111 (Super Metal) to rebuild and install patch plates for through-wall defects. Belzona 4341 (Magma CR4) was applied for internal protection.

External UV protection provided by the Belzona 5111 (Ceramic Cladding) coating

1. Both the internal and external surfaces of the oil–water strainer were grit blasted to Sa 2.5 cleanliness, achieving a minimum surface profile of 75 microns, in accordance with the Belzona Instructions for Use (IFU).
2. The through-wall defects were sealed using a patch plate that was cold bonded to the casing. The internal geometry of the strainer was then rebuilt using Belzona 1111 (Super Metal).

3. Following the repair, the internal surfaces were protected with Belzona 4341 (Magma CR4), applied in two coats to achieve a minimum dry film thickness (DFT) of 750 microns.

4. The external surfaces were subsequently protected with Belzona 5111 to provide long-term corrosion and UV protection.
