Transformer Fins Leak Repair Using Belzona

ID: 10167

Industry: *Transport*
Application: *TCC-Tanks and Chemical Containment Areas*
Substrate: *Carbon steel*
Products: *Belzona 1212*

Customer Location: *Saudi Arabia*
Application Date: *April 2025*

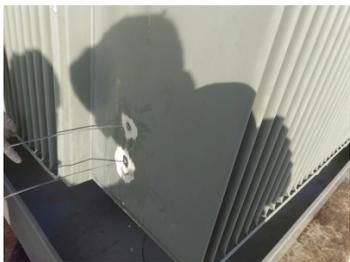
The customer experienced a leak in one of their oil transformer fins caused by external corrosion. Replacing the fins was not feasible due to the long lead time for new components.

Leakage in the Transformer Fins

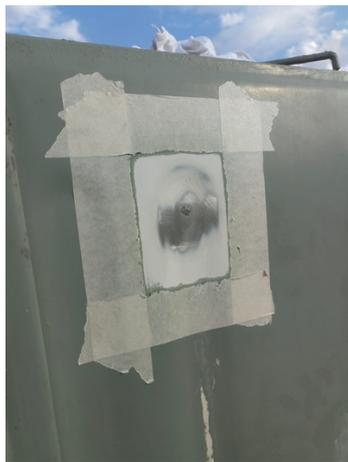
Surface Preparation of the Leakage Area

1. The leaking area on the transformer fin was thoroughly cleaned and abraded using power tools.
2. Belzona 1212 with 9341 reinforcement sheet was applied to restore the surface and stop the leak.

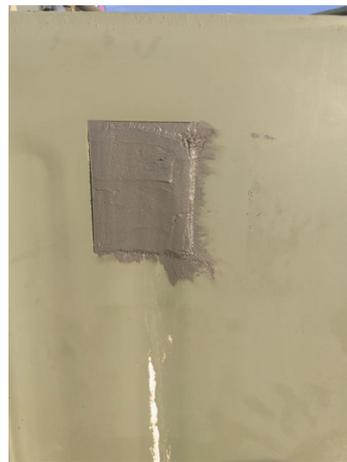
Application of Belzona 1212 with Belzona 9341 Reinforcement Tape
