# Flue Gas Compressor Index Cover Repair and Coating with Belzona

ID: 10168

Industry: Food & Drink  
Application: PDP-Positive Displacement Pumps

Substrate: Cast Iron  
Products: Belzona 1391T, Belzona 1511 (Super HT-Metal)

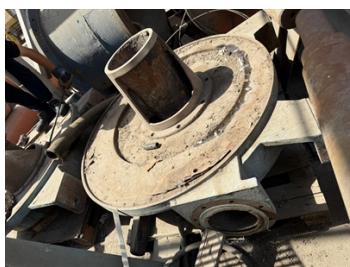
The pump cover had suffered severe erosion damage due to prolonged service conditions. As a result, the client classified the pump as scrap and placed it in the yard, assuming it was beyond economical repair.

Eroded pump cover

The erosion had reduced material thickness, adversely affected hydraulic profiles, and raised concerns regarding reliability and continued operation. The pump cover was repaired and coated at approximately 20% of the cost of a new pump.

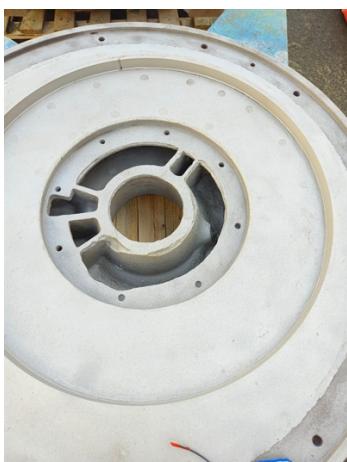
Surface preparation carried out by grit blasting

The pump cover was grit blasted to remove corrosion and achieve the minimum required surface profile. The eroded areas were rebuilt using Belzona 1511 (Super HT-Metal). A two-coat system of Belzona 1391T was then applied to provide long-term protection against erosion and corrosion.

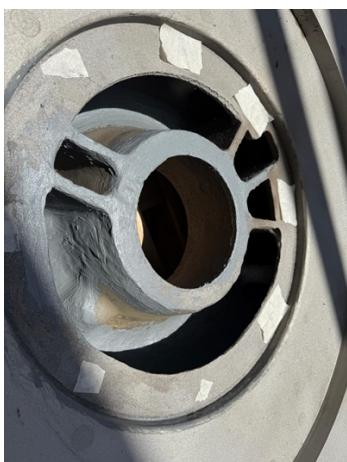
Surface rebuilt using Belzona 1511 (Super HT-Metal)

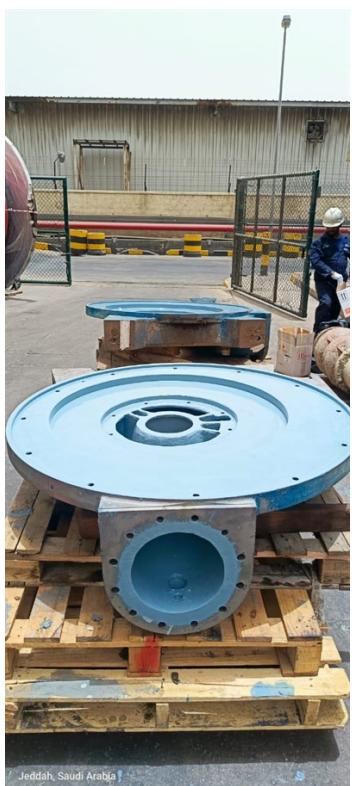
Pump cover coated with Belzona 1391T
