Damaged Pump Parts Repair by Belzona Solution

ID: 10171

Industry: Power
Application: CEP-Centrifugal Pumps
Substrate: Carbon steel
Products: Belzona 1121 (Super XL-Metal), Belzona 1331, Belzona 1341 (Supermetalglide)

Customer Location: Bangkok, Thailand
Application Date: September 2020

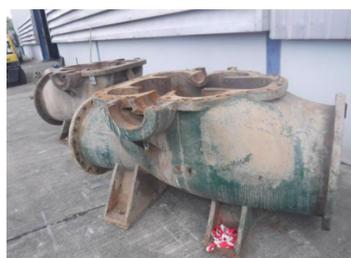
Pump components, including pump casing and pump impellers, were reported to have suffered from both corrosion and erosion damage. These issues affected the pump's operational efficiency and reliability. To avoid a high cost of pump replacement and operation downtime, the client contacted Belzona for a solution.

Damaged pump casing was delivered to the workshop for repair

The severely pitted areas were filled with Belzona 1121 (Super XL-Metal), a two-component paste grade system with extended working life for repairing and rebuilding machinery and equipment.

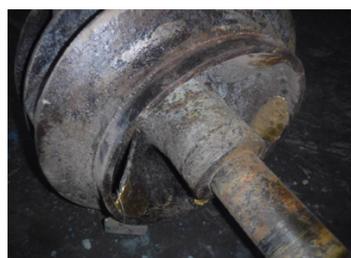
Damaged pump impeller before the repair

Belzona 1331 is specifically designed to protect immersed surfaces of machinery and equipment exposed to erosion-corrosion, providing long-term surface protection and performance reliability.

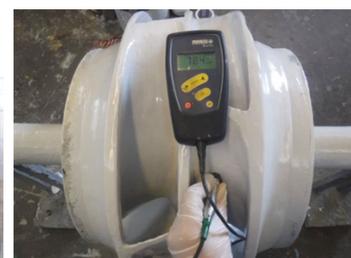
Pinhole check on pump impeller after Belzona 1331 coating
