Repair and Protection of Turbine Stay Vanes

ID: 10174

Customer Location: Rangipo
Application Date: November 2025

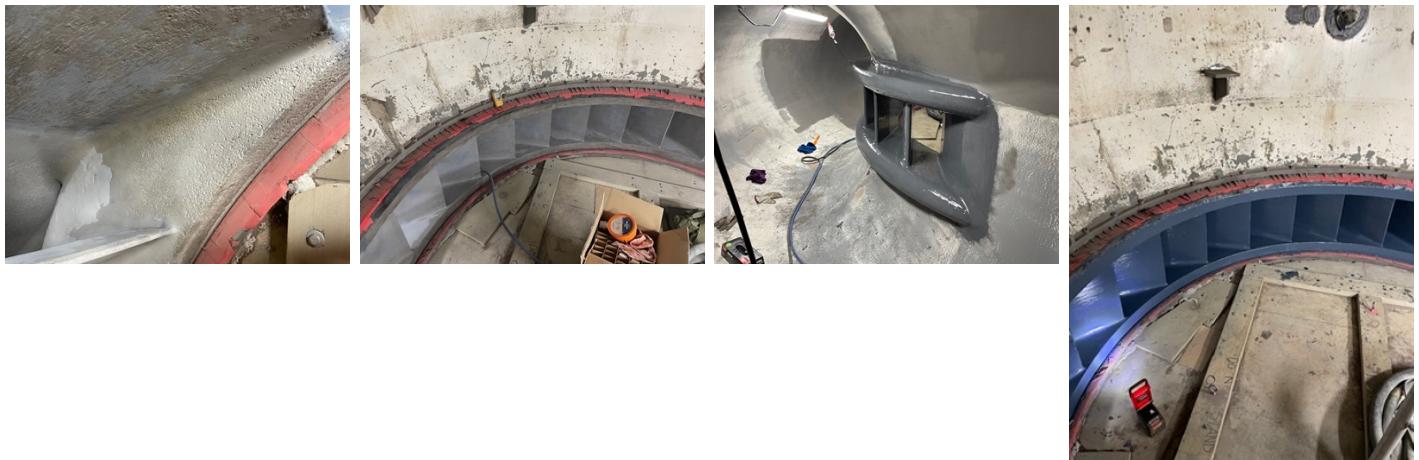
Damage to the previous coating and substrate caused by grit and rocks in the water used to turn the turbine

Blast cleaning to remove any rust and loosely adherent coating

The first coat of Belzona 1321 grey (detail)

The completed second coat of Belzona 1321 blue

The stay vanes were grit blasted with an angular abrasive in-line with the Belzona specification and damage to the leading edges was repaired with Belzona 1311 Ceramic R metal. Once stable the Belzona 1311 was sanded and the whole stay vane assembly coated in two coats of Belzona 1321 Ceramic S metal to an average wet film thickness of 375 microns per coat.
