Repair and Coating Split Case Pump and Impeller by Belzona

ID: 10176

Problem

Split case pump and impeller were reported with severe erosion-corrosion damage.

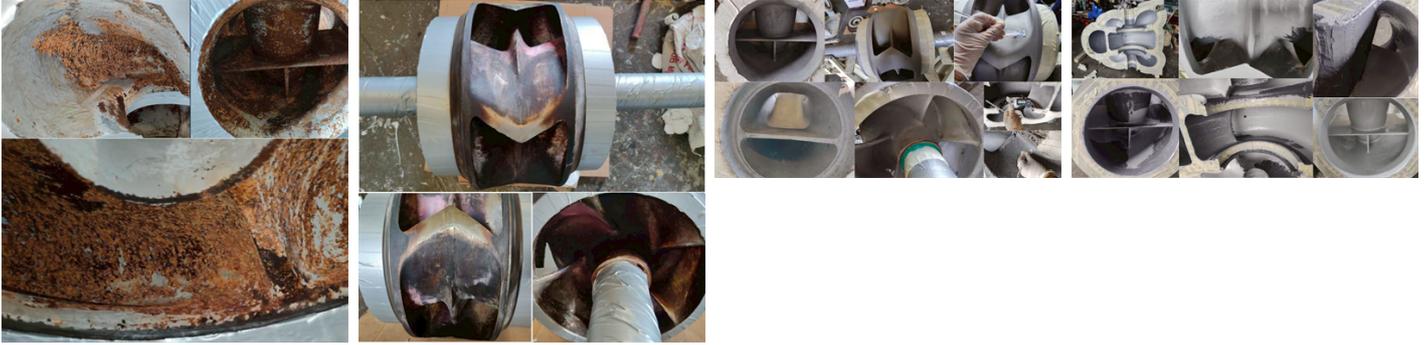
Corroded surface area on pump casing

Corroded surface on impeller

Surface was sandblasted and cleaned with Belzona 9111 (Cleaner Degreaser) to give minimum profiles at 75 microns and surface cleanliness by standard Sa 2.5.

Application of Belzona materials on pump parts to rebuild pitted area and overcoat to protect against erosion-corrosion

1. Carbon steel surface was prepared by sand blasting to give minimum profiles at 75 microns and surface cleanliness prepared to ISO 8501-1 Sa 2.5 standard.
2. Clean and brush away and loose contaminant and then, clean the surface with Belzona 9111 (Cleaner Degreaser)
3. Check salt containment on the surface by the salt contamination meter SCM 400. The salt content should be less than 4 ug/cm². If more than 4 ug/cm² was detected, the surface was then rewashed or re-blasted accordingly.
4. Once the desired profile was achieved, apply the first layer of Belzona 1331 at a dry film thickness of 250 microns.
5. The corroded area was filled with Belzona 1311 (Ceramic R Metal).
6. Apply the second coat of Belzona 1331 at dry film thickness 250 microns.
7. Check dry film thickness with PHYNIX DFT Tester.
8. Use the PCWI Low Voltage Tester to check the pinhole.

The proposed system incorporates Belzona 1311 (Ceramic R-Metal), which was used to rebuild areas damaged by erosion and corrosion.

For long-term protection, Belzona 1331 is applied as the coating. This material is specifically designed to protect the immersed surfaces of machinery and equipment, making it highly suitable for pump components that handle fluid transfer.
