# Pump Components Repaired and Protected with Belzona Systems

Industry: Other  
Application: CEP-Centrifugal Pumps  
Substrate: Carbon steel  
Products: Belzona 1311 (Ceramic R-Metal), Belzona 1331, Belzona 9111 (Cleaner Degreaser)

Customer Location: Thailand  
Application Date: October 2025

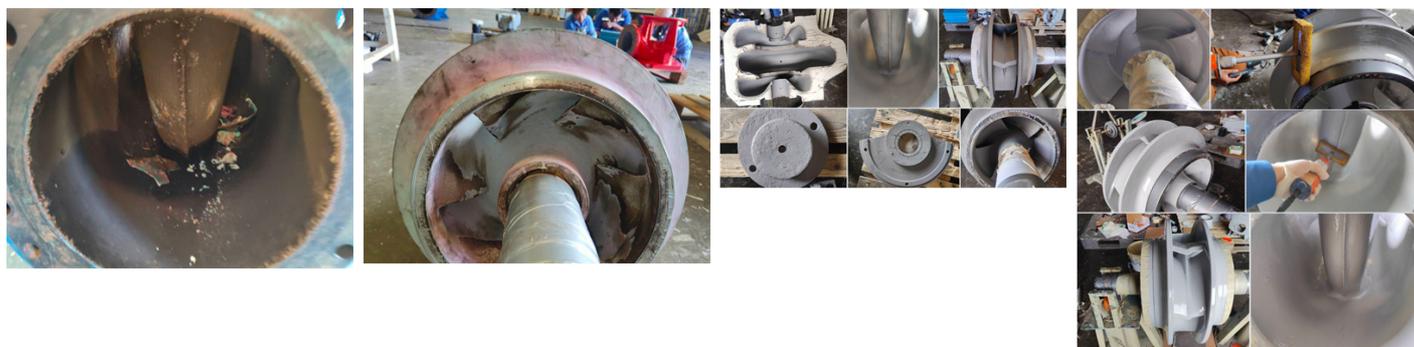
Corrosion and erosion damage on the lower pump casing.

Damage to the impeller caused by erosion and corrosion.

Surface preparation was carried out by sandblasting before the application of Belzona products.

The repair was completed and followed by a pinhole inspection before returning the pump parts to service.

The pump parts were transported to the workshop of the Belzona Authorised Distributor in Thailand for repair. Due to the significant surface loss observed in several areas of the pump components, the proposed solution involved the use of a Belzona paste-grade material to rebuild the original surface profile, followed by the application of a Belzona coating grade to provide additional protection against erosion and corrosion during service.

1. The carbon steel surfaces of the pump casing and impeller were prepared by sand blasting to achieve a minimum surface profile of 75 microns and a surface cleanliness of Sa 2.5.
2. Loose contaminants were removed by brushing. The surface profile was then verified using Testex Tape and a surface profile gauge.
3. The surfaces were cleaned using Belzona 9111 (Cleaner/Degreaser) to ensure the salt contamination level was below  $4 \mu\text{g}/\text{cm}^2$ .
4. Once the required surface profile had been achieved, the first coat of Belzona 1331 was applied at a dry film thickness (DFT) of 250 microns.
5. Belzona 1311 (Ceramic R-Metal) was used to rebuild areas where severe metal loss had occurred.
6. A second coat of Belzona 1331 was then applied at a DFT of 250 microns.

7. After curing, the coating thickness was verified using a Phynix DFT tester.
8. A PCWI low voltage holiday detector was used to perform pinhole inspection.
