# Cost-Effective Pump Repair Using Belzona Composite Solutions

ID: 10178

Industry: *Other* Customer Location: *Thailand*  
Application: *CEP-Centrifugal Pumps* Application Date: *July 2025*  
Substrate: *Carbon steel*  
Products: *Belzona 1311 (Ceramic R-Metal), Belzona 1331, Belzona 9111 (Cleaner Degreaser)*

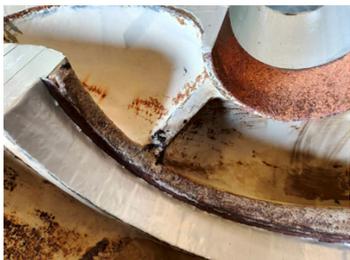
The upper and lower areas of the pump casing were reported with corrosion damage. The pump impeller was also damaged and needed repair to restore the pump's performance and efficiency. Rather than replacing the entire unit of the pump, the client looked for a repair solution that was more cost-effective.

Corrosion on the upper pump casing

1. The pump components were delivered to the workshop for repair.
2. The carbon steel surfaces were prepared by sand blasting to achieve a minimum surface profile of 75 microns and a surface cleanliness by standard Sa 2.5.

3. Any loose contamination was removed by brush, followed by degreasing using Belzona 9111 (Cleaner/Degreaser).
4. Salt contamination on the prepared surfaces was measured using an SCM 400 salt contamination meter. The acceptable salt level was less than 4 µg/cm<sup>2</sup>. If readings exceeded this limit, the surfaces were rewashed or blasted again.

5. The first coat of Belzona 1331 was applied at a dry film thickness (DFT) of 250 microns verified by a PHYNIX DFT tester.
6. Areas with metal loss were rebuilt with Belzona 1311 (Ceramic R-Metal) to restore the original surface profile.

7. The second coat of Belzona 1331 was then applied at a DFT of 250 microns. Use the PHYNIX DFT tester to check DFT.
8. Prior to returning the pump components to the customer's premises, a pinhole inspection was carried out using a PCWI low-voltage tester.

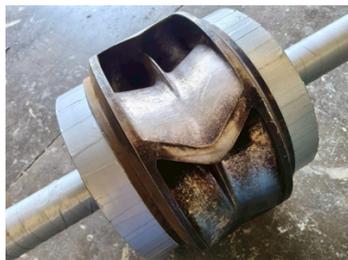
Corrosion on pump impeller
