# Belzona Repair Solution for Split Case Pump and Pump Impeller

ID: 10179

Customer Location: Thailand  
Application Date: June 2025

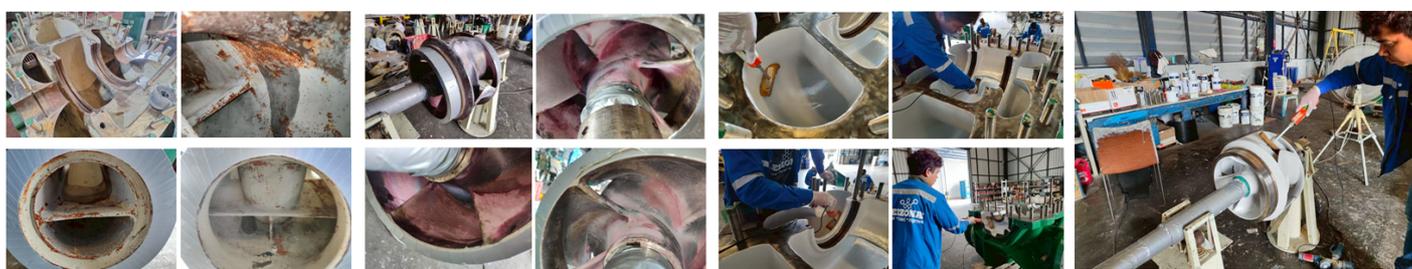
The pump components were damaged due to prolonged exposure to erosion and corrosion during service. This resulted in surface degradation, metal loss, and an uneven internal profile, which negatively affected efficiency and overall pump performance.

Corroded surface on lower casing

Pump impeller damaged by erosion&corrosion

Pinhole inspection on pump casing after the application was completed

Pinhole inspection on pump impeller after the repair was completed

1. Carbon steel surface on pump casings and impellers was prepared by sand blasting and cleaned with Belzona 9111 (Cleaner/Degreaser).
2. A minimum profile at 75 microns and surface cleanliness by standard Sa 2.5 was expected. TESTEX Tape and surface profile gauge were used to measure the profile.
3. Salt containment on the surface was measured to confirm that the salt content was below  $4 \mu\text{g}/\text{cm}^2$ .
4. Once the surface was ready, Belzona 1331 was applied as the first coat and to fill the holes.
5. For any severely metal loss areas, Belzona 1311 (Ceramic R-Metal) was used to fill.
6. Apply the second coat of Belzona 1331, a two-component fluid grade system for protecting immersed surfaces of machinery and equipment suffering from erosion-corrosion.

Belzona 1311 (Ceramic R-Metal) is a ceramic-filled erosion- and corrosion-resistant composite specifically designed to rebuild areas of metal loss. Its excellent adhesion to carbon steel and resistance to aggressive media make it ideal for filling voids and restoring the original profile of pump parts exposed to corrosive service conditions.

To provide long-term protection, Belzona 1331 was specified as the protective coating system. This material can be applied by both brush and spray, allowing flexibility during application while achieving a high-build without sagging. Once cured, it forms a durable barrier that protects pump components from erosion and corrosion, helping to improve operational performance and extend service life.
