BELZONA RAPID FLOOR REPAIR

ID: 1018

Application: *FPA-Floor Problem Areas*

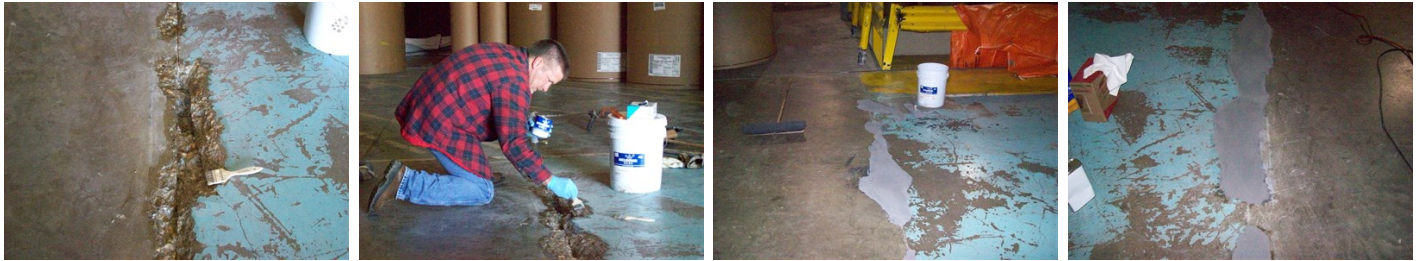
Photograph Descriptions

Hole in floor creating problem for fork lift drivers loading and unloading cardboard for box manufacture.

* Removed concrete from hole , * Belzona® 4911 being applied , * & 4. Finished application ,

Application was carried out in accordance with Belzona Know-How System Leaflet FPA-1.

The alternative was to saw cut concrete and pour new concrete. That would be more costly because of labor and down time in the area. It was possible to drive over the Belzona applied in morning that night.
