# Pump Casing Repaired with Belzona Materials

ID: 10180

Industry: Power  
Application: CEP-Centrifugal Pumps  
Substrate: Carbon steel  
Products: Belzona 1121 (Super XL-Metal), Belzona 1341 (Supermetalgilde)

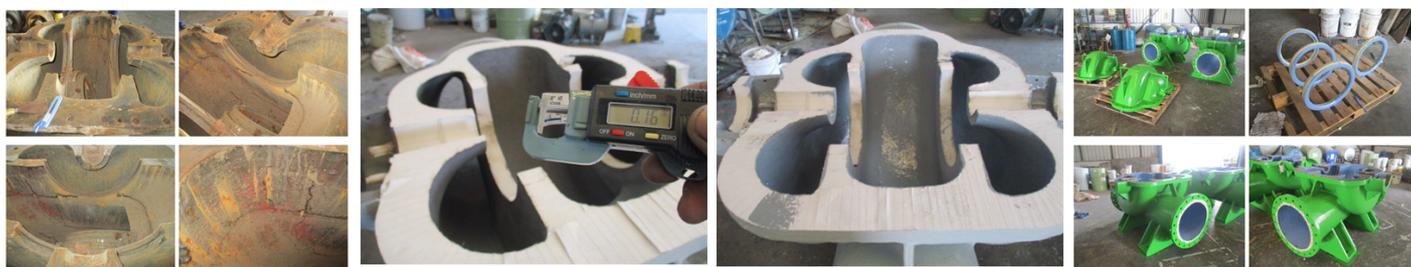
Severe damage on pump casing

Pump casing was prepared by using steel grit blasting until a minimum depth of 75 microns and Surface cleanliness by Swedish standard Sa 2.5 was achieved

The first coat of Belzona 1341 (Supermetalgilde) was applied on the prepared surface

Complete application on the pump casing

1. Steel grit blasting was used to prepare the surface of the pump casing. A minimum depth of 75 microns and Surface cleanliness by Swedish standard Sa 2.5 is expected.
2. Use Methyl Ethyl Ketone (MEK) to clean the surface. All loose materials on the casing were removed.
3. Apply the first coat of Belzona 1341 (Supermetalgilde) at a dry film thickness of 250 microns
4. On the pitting damage areas, use Belzona 1121 (Super XL-Metal) to fill.
5. Apply the second layer of Belzona 1341 (Supermetalgilde)
