Hydropower Draft Tube Rebuild

ID: 10181

Application: TCC-Tanks and Chemical Containment Areas

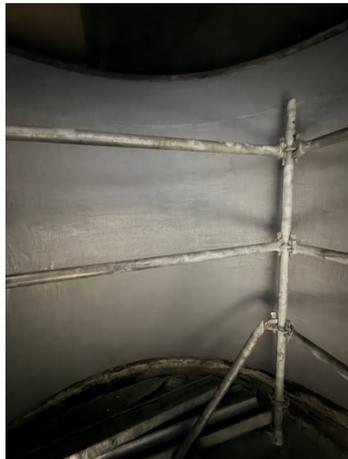
Blasted surface

200 square feet of carbon steel was grit blasted to a minimum of 3mils followed by rebuilding with Belzona 1121, then two coats of Belzona 1321. All work was performed in accordance with Belzona's instructions for use (IFU'S)

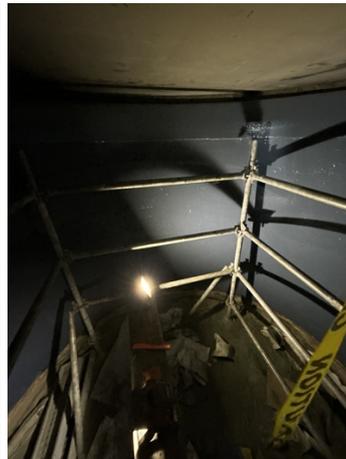
Belzona 1121 was used to rebuild pitting damage

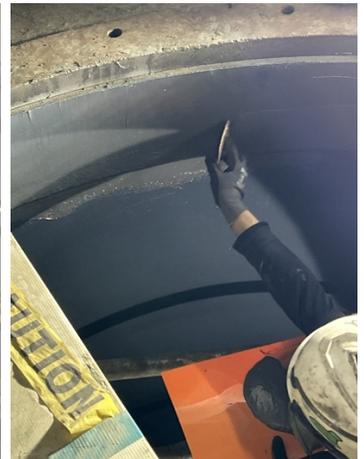
Belzona 1321 Blue first coat
