Stress crack corrosion repaired on interior of reactor

ID: 10182

Industry: Chemical & Petrochemical

Application: TCC-Tanks and Chemical Containment Areas

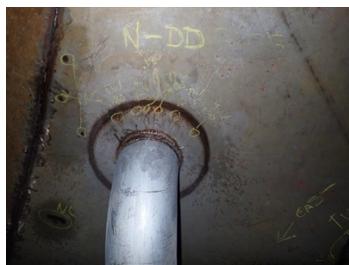
Customer was seeing stress, crack corrosion on the internal weld seems of their reactor, as well as pitting on the welds.

Stress, crack corrosion on welds around nozzle.

Welding on the stainless steel was only furthermore enhancing the cracking. The customer needed a cold solution that could stand up to the temperature of the reactor as well as process conditions.

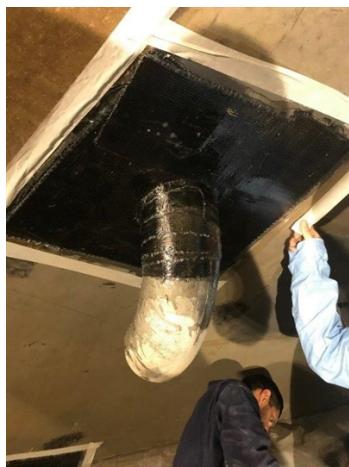
Area was blasted with aluminum oxide and Super Wrap II applied.

Each weld seem and area around the weld seem was blasted with aluminum oxide to provide a 3 to 4 mil profile on the stainless steel substrate.

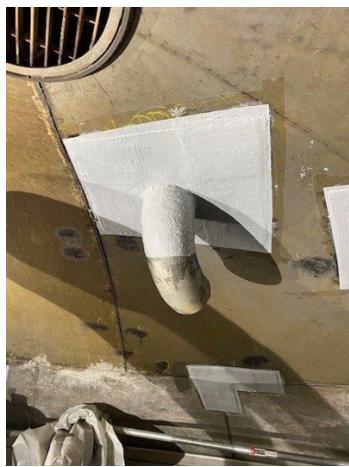
SuperWrap II was top coated with Belzona 5811 and 5111.

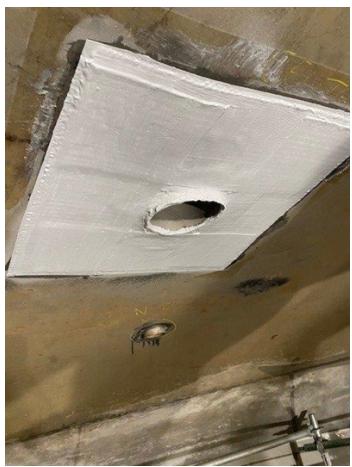
Secondary area completed with SuperWrap II and top coated with Belzona 5811 and 5111.
