Safety nonskid for office entry

ID: 10183

Industry: *Buildings & Structures*
 Application: *FPA-Floor Problem Areas*
 Substrate: *Concrete*
 Products: *Belzona 5231 (SG Laminate), Belzona 9221 (Surefoot Aggregate White)*

Customer Location: *Houston, TX*
 Application Date: *April 2014*

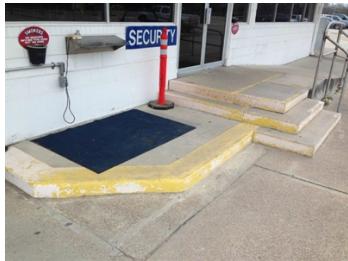
Non-skid safety markings leading into the customers engineering offices was wearing off after 14 years of service. The customer, a long time user of Belzona non-skid solutions was so impressed with the longevity of the 5231 that Belzona was their only choice to refresh the areas.

Worn Belzona 5231 areas from an application applied in January of 2000.

The surface was prepared by power washing to remove any loose coatings as well as dirt and debris. A diamond grinder was used to abrade the surface to provide an acceptable substrate. The first coat of 5231 was applied, then 9221 was broadcasted in for nonskid properties. A second coat of 5231 was applied within the overcoat window in accordance with the Belzona instructions for use.

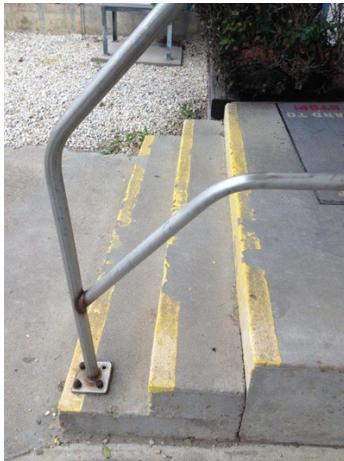
14 year old non-skid application.

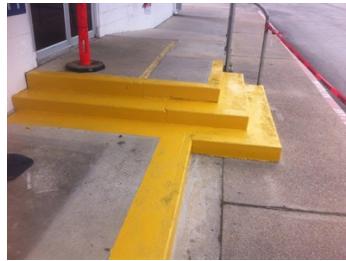
Areas refreshed with Belzona 5231 and 9221 Surefoot aggregate.

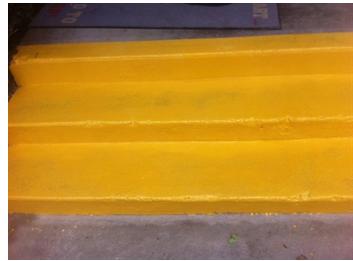
Refreshed and ready for another 14 years of service.
