Bell and Spigot Joint Sealed with Belzona Composite Repair System

Industry: Water / Wastewater

Customer Location: Morong, Bataan, Philippines

Application: VPF-Valves, Pipes and Fittings

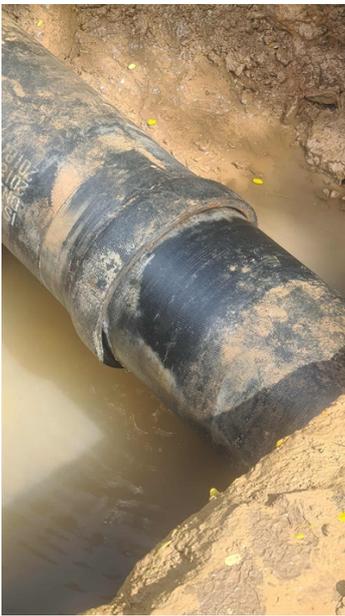
Water leakage was identified at the bell-and-spigot joint of an underground freshwater main pipeline located along a highway. The leakage was attributed to joint degradation and movement, which allowed water to escape through the joint interface. Due to the pipeline's location and operational constraints, pipe replacement or shutdown of the line was not feasible. An in-situ repair solution was therefore required to stop the leak and restore the pipeline's integrity.

Leak observed at the bell and spigot joint

The leaking bell-and-spigot joint was excavated and dewatered, and the leak was initially controlled by copper peening.

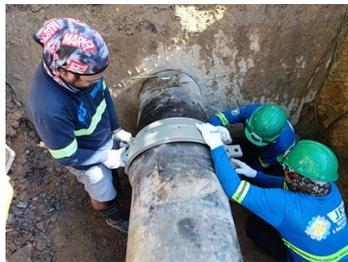
Installation of an engineered clamp

After mechanical surface preparation, Belzona 1212 was applied to seal and restore the joint, followed by Belzona 5811DW (DW Immersion Grade) for corrosion protection. An engineered repair clamp was then installed and sealed, after which Belzona 9381 Reinforcement sheet, saturated with Belzona 1982 (SuperWrap II) resin, was wrapped around the joint and consolidated using Belzona 9382 release film, providing long-term structural reinforcement and a leak-free repair.

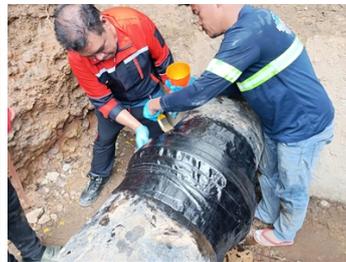
Application of Superwrap II

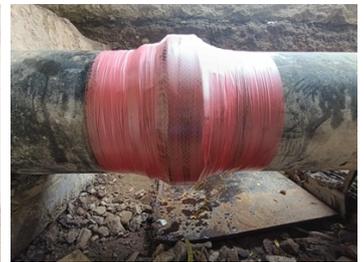
Application of release film wrapping completed
