NaOH Vessel lined with Belzona 1391S/T for large Petrochemical site

ID: 10193

Application: TCC-Tanks and Chemical Containment Areas

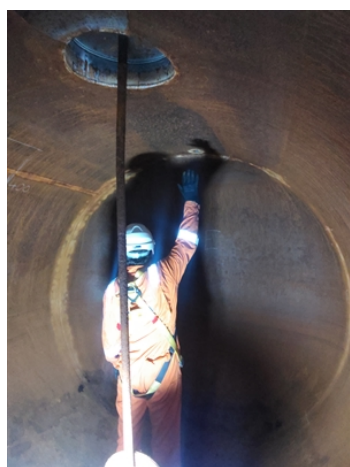
Taking measurements within the vessel on primary visit of the tank. The image provides a rough view of the diameter of the vessel, including some of the man way / nozzles requiring coatings too.

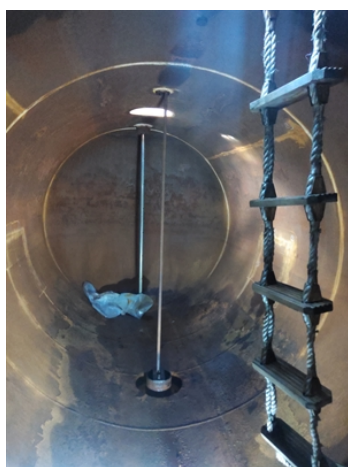
Another internal view of the vessel, highlighting the the weld joints and rough idea of length of the vessel.

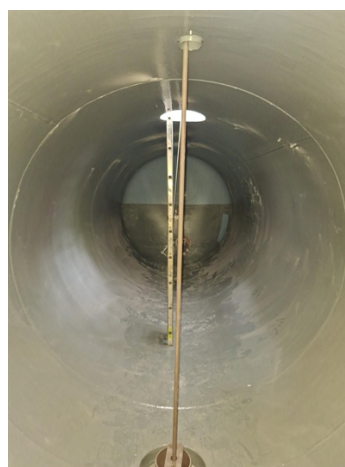
Following application with some hand applied remedial area already coated.

The vessel was heated to maintain constant environmental conditions. The vessel was grit blasted to a profile of >75 micron average at a cleanliness of SA2.5. Spray application was required with stripe coating and hand applied remedial works following full lining.

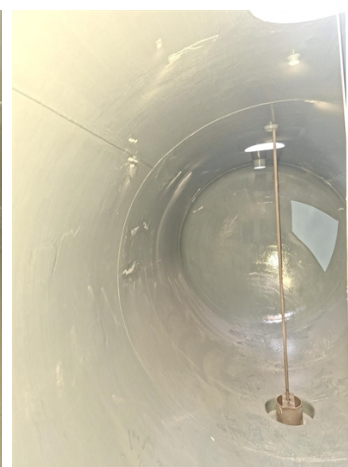
A further view following application highlighting further remedial areas that were going to be coated using 1391T.

All nozzle and man ways were hand applied.
