Belzona Keeps Floating Hoses Afloat

ID: 10195

Industry: Oil & Gas
Application: SOS-Ships and Offshore Structures

Customer Location: Balongan - Indonesia
Application Date: May 2025

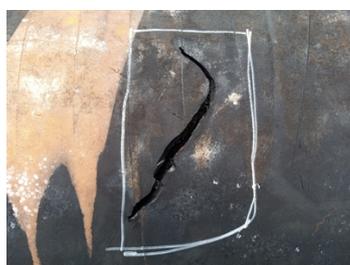
Twenty-four floating hose units in a refinery facility had experienced significant wear and tear on their rubber components in several locations, requiring immediate in-situ repair to maintain buoyancy and ensure proper operation. Without timely maintenance, the damaged rubber surfaces could deteriorate further, potentially disrupting operations and compromising the efficiency and safety of transfer activities within the refinery.

Damaged hose before repair using Belzona.

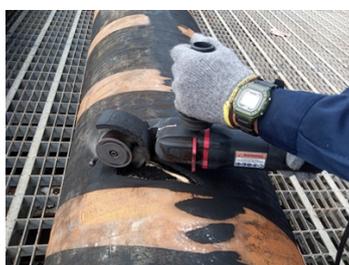
Surface preparation using an MBX Blister Blaster to roughen the rubber substrate.

1. The surface was prepared using an MBX Blister Blaster to roughen the rubber substrate.

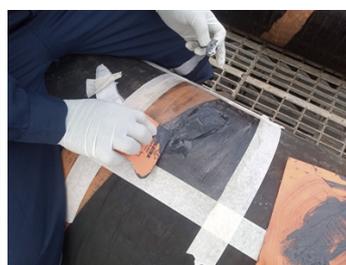
Reconditioning of the damaged area using Belzona 2211 (MP Hi-Build Elastomer) and Belzona 9341 (Reinforcement Tape).

2. Belzona 2921 (Elastomer GP Conditioner) was applied following completion of surface preparation.
3. The damaged area was rebuilt using Belzona 2211 (MP Hi-Build Elastomer) reinforced with Belzona 9341 (Reinforcement Tape).
4. Belzona 2221 (MP Fluid Elastomer) was applied as the final coat.

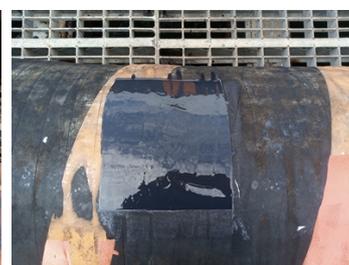
Final appearance after application of Belzona 2221 (MP Fluid Elastomer).

The repair process commenced with the application of hi-build elastomer to rebuild the damaged rubber surface, followed by the application of fluid-grade elastomer as the final coat to strengthen and protect the repaired area.
