# Belzona Restores 18 Stripped Threads on Yacht

ID: 10202

**Industry:** Marine  
**Application:** ENC-Engines and Casings  
**Substrate:** Carbon steel  
**Products:** Belzona 1111 (Super Metal), Belzona 1121 (Super XL-Metal), Belzona 9111 (Cleaner Degreaser), Belzona 9411 (Release Agent)

**Customer Location:** Palma  
**Application Date:** December 2025

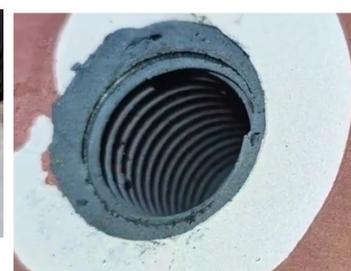
Once the bolt and substrate are wet out the bolt can be inserted into the hole.

Complete application showing restored thread

Once Belzona 1111/1121 was mixed, both the bolt holes and the bolt threads were wet-out before additional material was injected. The bolts were then inserted using a twisting motion. The Belzona was allowed to cure in accordance with its IFU.
