Providing durable anti-slip protection of factory stairways

ID: 10203

Industry: *Cement* Customer Location: *Croatia*
 Application: *FPA-Floor Problem Areas* Application Date: *August 2024*
 Substrate: *Concrete*
 Products: *Belzona 5231 (SG Laminate), Belzona 9221 (Surefoot Aggregate White)*

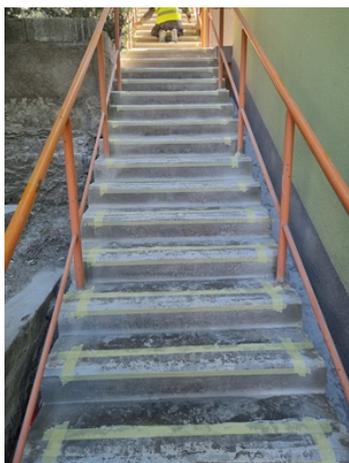
Stairway in a cement plant needed anti-slip protection in order to prevent tripping and injuries.

Situation before application and surface marking with masking tape

Stairway in a cement plant is used by majority of employees as well as subcontractors and guests. The surface of the stairs is smooth, which poses a risk of falls and injuries.

Application was carried out in accordance with Belzona Know-How System Leaflet FPA-8. Surfaces were grinded using angle grinders and thoroughly washed with pressurized water and detergent in order to remove settled impurities. Positions of anti-slip strips were marked using masking tape. Belzona 5231 was applied with short bristled brush with Belzona 9221 (Surefoot Aggregate White) incorporated.

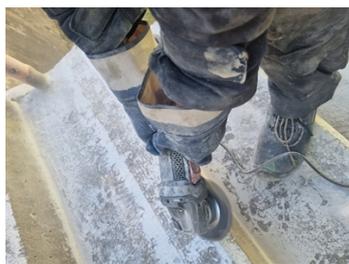
Surface preparation using angle grinders.

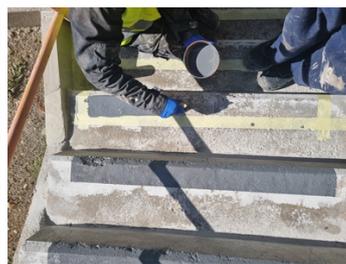
Application of Belzona 5231 in progress.

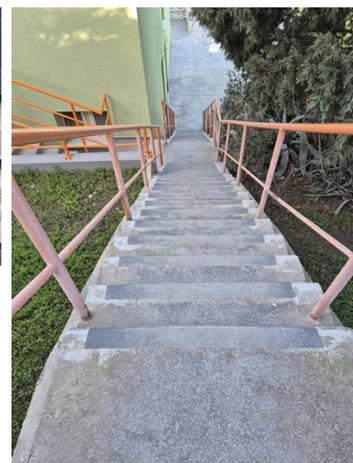
Situation after 18 months – still in perfect condition.

perfect condition. Customer was satisfied and we got more similar jobs after this.
