# Correctional Facility Bathroom Floor

ID: 10207

Application: FPA-Floor Problem Areas

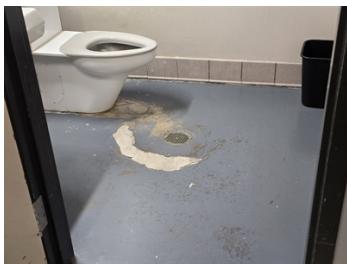
Areas surrounding the floor drain had previously been repaired using a patch material; however, the repair system failed over time due to continued service conditions and deterioration. The failed patch material had become loose and damaged, resulting in an uneven surface and further degradation around the drain area, requiring complete removal and restoration.

Condition prior to repair

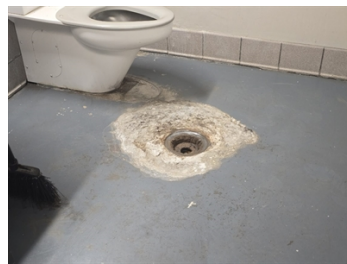
Removal of previous patch material

A hammer and chisel was used to remove the previous patch, and then a wire wheel on a drill was used to remove all loose materials. A concrete diamond grinding wheel was also used.

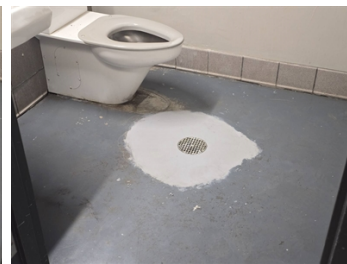
Application of Belzona 4111

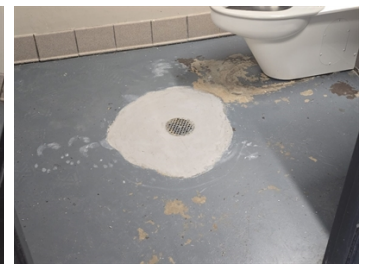
Another bathroom floor restored
