BELZONA PROTECTION AGAINST EROSION-CORROSION IN NEW HEAT EXCHANGERS

ID: 10208

Industry: Oil & Gas
Application: HEX-Heat Exchangers
Substrate: NAB Nickel Aluminum Bronze
Products: Belzona 1391T

Customer Location: Batam, Indonesia
Application Date: August 2025

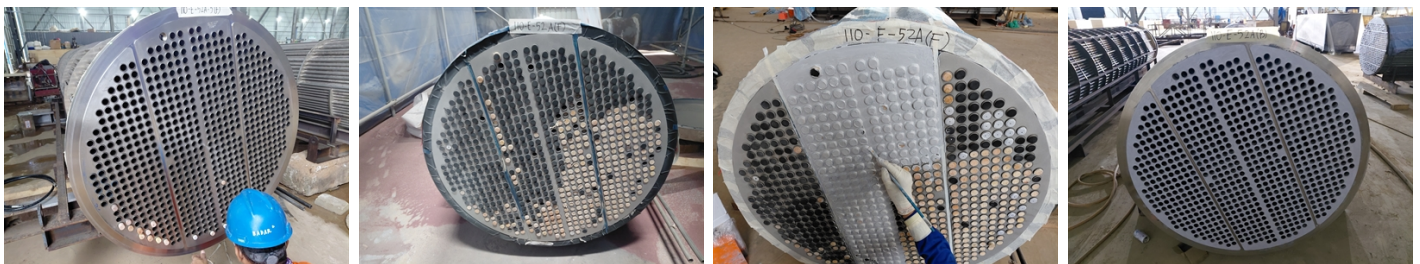
Corks and bungs were installed in the tubes on the tube sheet.

Tube sheet abrasively blasted to achieve the correct substrate profile

Application of 2 coats system of Belzona 1391T

Completed Belzona 1391T coating application

Application was carried out in accordance with Belzona Know-How System Leaflets HEX-3. Prior to the application of Belzona 1391T, the surface was prepared by abrasive blasting to achieve a cleanliness of Sa 2½ whilst achieving a minimum average surface profile of 75 microns. Subsequently, the application of a 2-coat system of Belzona 1391T was carried out.
