# Belzona Solutions for Rebuilding and Coating of Wave Generation Tyre Rims

ID: 10213

Customer Location: Abu Dhabi, United Arab Emirates

Application Date: February 2026

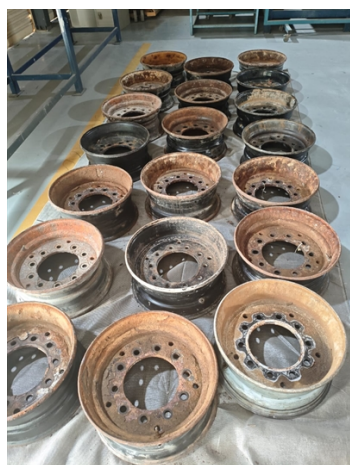
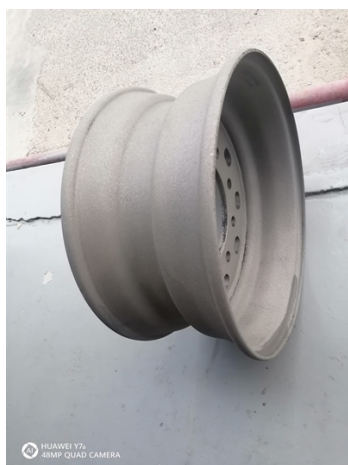
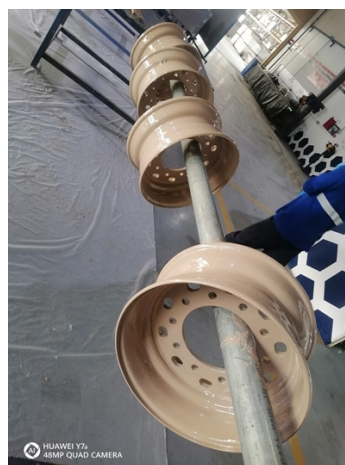
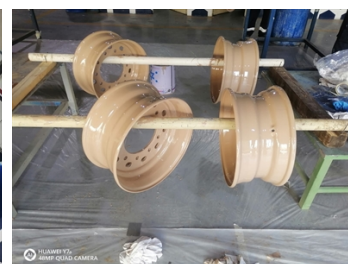
The tyre rims of the wave-generation system have developed corrosion, which could result in air leakage within a short period of operation if not addressed.

The procedure began with grit blasting to obtain the specified surface profile, followed by thorough surface cleaning using Belzona 9111 (Cleaner Degreaser).

The pitted areas were subsequently restored using Belzona 1121 (Super XL-Metal) in accordance with the Belzona Instructions for Use (IFU). Upon completion of curing, the first coat of Belzona 5811 was applied.

Finally, a two-coat application of Belzona 5811 (Immersion Grade) was carried out in accordance with the IFU guidelines, ensuring long-term corrosion resistance and durable protection.
