Belzona Repair of Leakage on a Diesel Fuel Storage Tank

ID: 10214

Customer Location: Mount Maunganui, New Zealand

Application: TCC-Tanks and Chemical Containment Areas

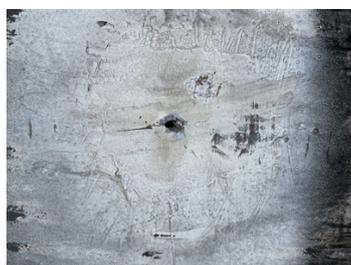
The customer identified a small leak originating from behind an existing doubler plate that had been installed decades ago, with no records available. The area in question was approximately 8 m above ground level. When the original plate was removed, a small circular dent was observed with a hairline crack of approximately 1 mm above it. Diesel from the tank was weeping through this crack and beneath the plate.

Original defect after cleaning and degreasing.

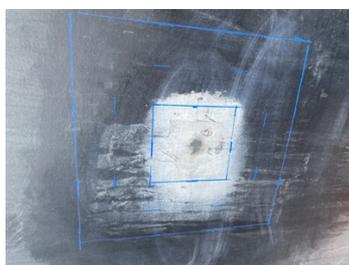
The defect area was filled with Belzona 9611 (ES-Metal) as a temporary measure to allow hot-work surface preparation of the surrounding repair area.

An area 100 mm square was marked out, cleaned, and degreased. The crack was then terminated and sealed with Belzona 9611 (ES-Metal) as a temporary measure required by the customer prior to granting a hot-work permit.

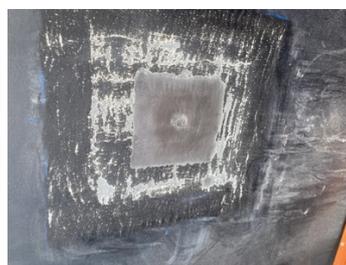
Surface preparation of the area including cutting in area for the paint to overlap.

Once a gas sniffer had been used to declare the area gas-free, an MBX tool was used for surface preparation. The area was cleaned and degreased once again, and a new doubler plate was bonded in place using Belzona 1161 (Super UW-Metal).

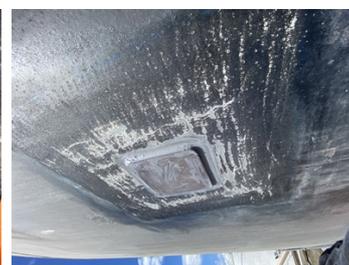
Doubler plate installed with chamfered edges, ready for painting.

The repair was held in position with a magnet until cured and was then overcoated with the specified paint system.
