Emergency Repair of a 140 °C Liquid Sulfur Tank with Belzona

ID: 10218

Industry: Chemical & Petrochemical
Application: TCC-Tanks and Chemical Containment Areas
Substrate: Carbon steel
Products: Belzona 1593, Belzona 1983 (SuperWrap II)

Customer Location: Tuscany, Italy
Application Date: April 2025

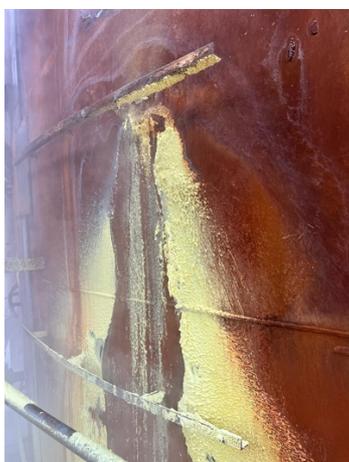
A liquid sulfur storage tank operating at approximately 140 °C experienced progressive internal corrosion, which eventually led to the formation of a through-wall defect on the shell. This defect caused a loss of containment, with liquid sulfur leaking from the tank. The deterioration was localized in an area where corrosion mechanisms had weakened the internal surface over time, ultimately compromising the structural integrity of the shell

Original view of the liquid sulphur leakage

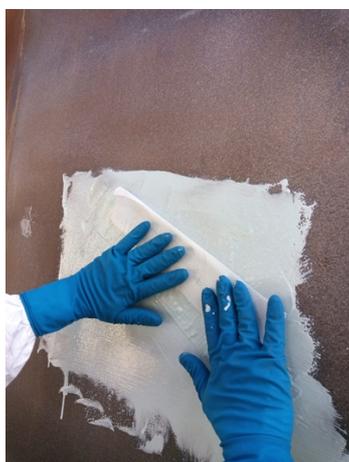
Initial sealing with Belzona 1593 and reinforcement tape Belzona 9341

After a thorough and carefully controlled abrasive blasting of the external shell, Belzona 1593 together with the Belzona 9341 reinforcement tape were applied as the first interface directly over the through-wall defect. Subsequently, a structural reinforcement using the Belzona SuperWrap II system (Resin grade 1983) was installed

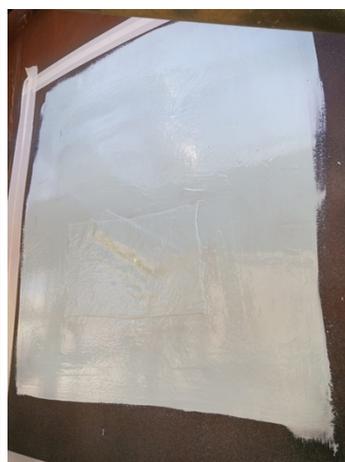
Completed application of Belzona 1593 initial interface layer.

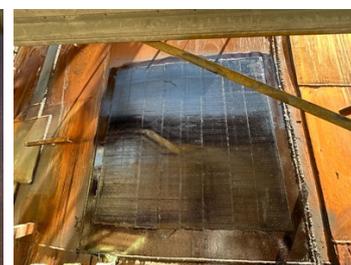
Completion of the structural reinforcement using Belzona 1983 for Superwrap II system
