Belzona SF6-FIX Leak Sealing Solution to Complex Geometry

ID: 10223

Industry: Power
Application: GSS-Gaskets, Seals and Shims
Substrate: Cast Iron
Products: Belzona 1981 (SuperWrap II), Belzona SuperWrap II, Belzona 7311

Customer Location: Faversham
Application Date: March 2026

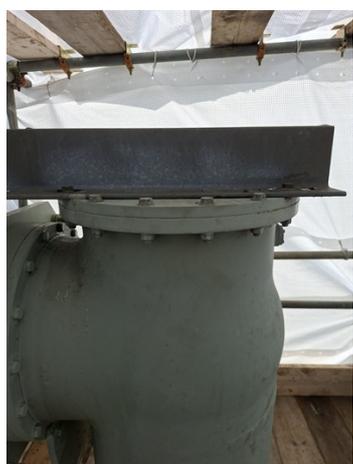
End plate with steel girder resting on top creates difficult geometry to execute repair

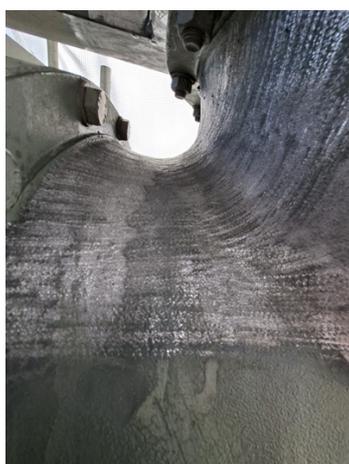
Hand tools are used to clean the area and create a minimum surface profile for application

The area between the flange faces will remain undisturbed, with surface preparation limited to the landing areas on either side of the gasket/neck. Surface preparation will be carried out using 110v power tools, including grinders fitted with flap wheels and specialist rotating wire wheels. The prepared surface will form a 150mm-wide band around the full circumference of the equipment. The full Belzona® SF6 Repair System will be applied during a single work shift. Following application, the repair will be left to cure overnight, with a breather pipe installed and left open to allow off-gassing during the mechanical cure process. On the following day, a full inspection will be conducted.

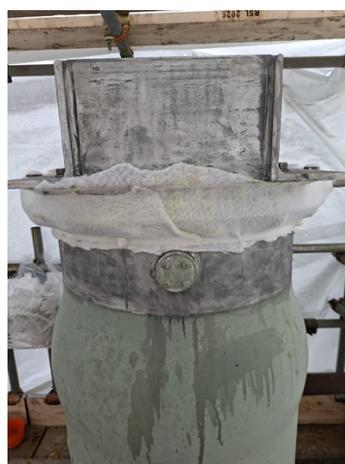
First stages of SF6 solution

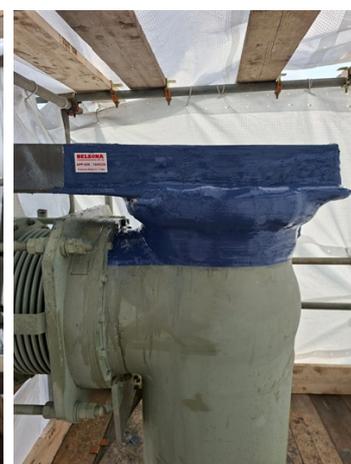
Completed application of bespoke SF6 solution
