# Parking Garage Concrete Wall Repair Using Belzona 4141

ID: 10230

Application: WPA-Wall Problem Areas

Application Date: June 2025

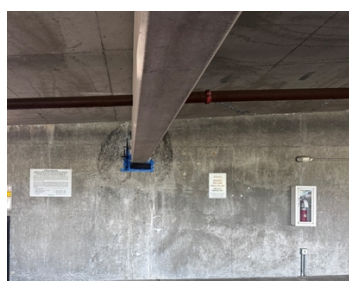
A concrete wall within a parking garage structure had suffered significant deterioration due to prolonged water intrusion. Moisture penetration through the concrete had initiated corrosion of the embedded steel reinforcement, causing the rebar to expand and delaminate the surrounding concrete. This resulted in widespread spalling across the wall surface, exposing corroded rebar and leaving the structural concrete vulnerable to further degradation. Left unrepaired, the ongoing cycle of water intrusion, rebar corrosion, and concrete spalling would continue to accelerate, compromising the structural integrity of the wall and creating a potential safety hazard for vehicles and pedestrians within the parking facility. The customer required a durable, long-term repair solution capable of rebuilding the damaged concrete profile, encapsulating the corroded reinforcement, and withstanding the harsh conditions typical of a parking garage environment.

Before

All loose and delaminated concrete was removed by chipping and breaking back to sound substrate, fully exposing the corroded rebar including hidden faces behind the reinforcement. Exposed rebar was mechanically abraded to remove loose rust and scale, achieving a rough bright metal surface. The prepared concrete substrate was vacuumed to remove all dust and debris.

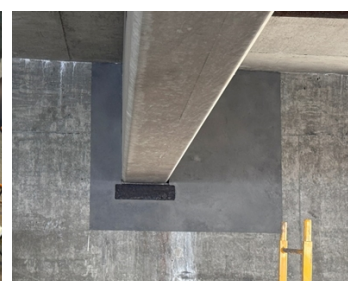
Completed Application

The mixed Belzona 4141 was applied by gloved hand and worked firmly into the damaged areas, building up the material proud of the surrounding concrete profile. The repair surface was then finished and leveled using standard trowels, cleaned frequently with a damp cloth to achieve a smooth, consistent finish flush with the adjacent wall surface.

The total application time was approximately 4 hours. The repair was left undisturbed and reached full mechanical strength within 24 hours, at which point the wall was returned to full service.
