Z-Drive Repair Using Belzona 1111 and 5821

ID: 10231

Industry: Marine
Application: SOS-Ships and Offshore Structures

Substrate: Carbon steel
Products: Belzona 1111 (Super Metal), Belzona 5821

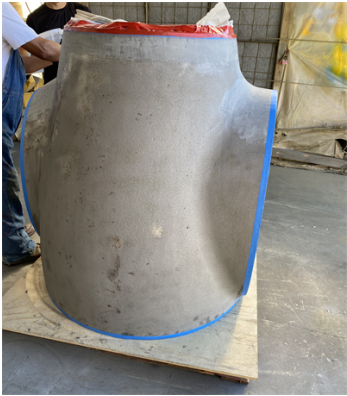
The azimuth nozzle on a Z-drive propulsion system was experiencing cavitation erosion caused by the high-velocity turbulence generated by the propeller during normal operation. The carbon steel nozzle surfaces showed significant material loss across approximately 20 square feet of affected area, with pitting and surface irregularities characteristic of sustained cavitation damage in a seawater immersion environment. The combination of cavitation forces and the corrosive effects of saltwater service accelerated the rate of deterioration. If left unaddressed, continued material loss would compromise the hydrodynamic profile of the nozzle, reducing propulsive efficiency and eventually threatening the structural integrity of the assembly. A durable repair and long-term protective coating solution was required to restore the nozzle geometry and prevent recurrence.

Before

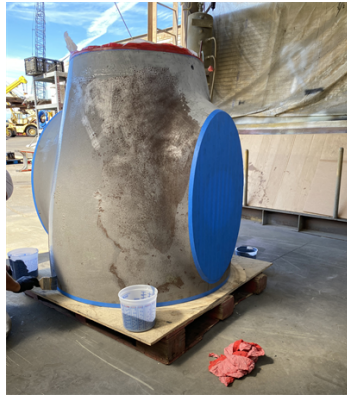
After Blasted

The damaged carbon steel surfaces were abrasive blasted to SSPC-SP10 Near-White Blast Cleaning standard, achieving a minimum 3-mil angular surface profile suitable for mechanical adhesion of the Belzona system. Belzona 1111 (Super Metal) was then mixed and applied by spatula and gloved hand to rebuild the cavitation-damaged areas, restoring the nozzle surfaces to their original

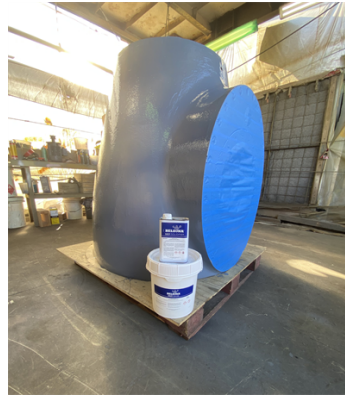
Belzona 5821 First Coat

profile and geometry. Once the rebuild was complete and had reached initial set, Belzona 5821 was applied as a protective immersion-grade coating over the rebuilt surfaces and surrounding substrate to provide long-term resistance to both cavitation and seawater corrosion. The total application time for the complete system was approximately four hours. All products were mixed and applied in accordance with Belzona's Instructions for Use (IFU's). The repaired nozzle was allowed a three-day ambient-temperature cure before the vessel was returned to service.

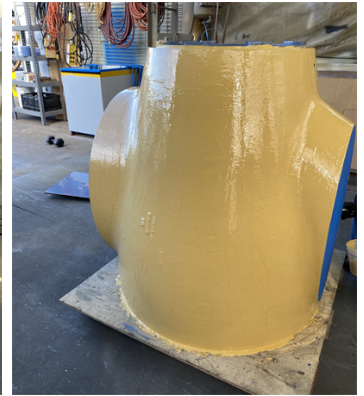
Belzona 5821 Second Coat
