# In-situ Sealing of SF6 Gas Leak on GIS Equipment Using Belzona SF6-Fix System

ID: 10232

Industry: Power  
Application: GSS-Gaskets, Seals and Shims  
Substrate: Carbon steel  
Products: Belzona 1983 (SuperWrap II), Belzona SuperWrap, Belzona 5721, Belzona 7311, Accessories

Customer Location: Saudi Arabia  
Application Date: February 2026

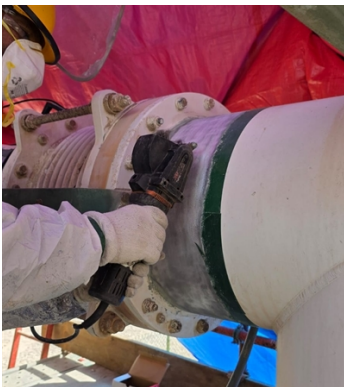
Surface preparation of bond areas in accordance to SSPC-SP 11 using MBX Bristle Blaster.

All bond areas were prepared to SSPC-SP 11 standard using an MBX bristle blaster, and surfaces were cleaned to remove contaminants.

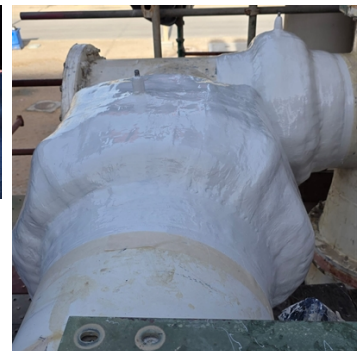
Application of Belzona 9371 reinforcement sheets wet out with Belzona 1983 SuperWrap II resin.

Next, larger Belzona 9371 (250 mm) reinforcement sheets were saturated with Belzona 1983 SuperWrap II resin and applied over the repair area with 50 % overlap, smoothing out air bubbles and creases. Pre-cut 80 mm 9371 sheets were then saturated and wrapped circumferentially around the flange ends and breather tube to secure the system. This process was repeated until five complete layers of 9371 had been applied. Finally, a top layer of 7311 was applied to fully encapsulate the wrap.
