# Shaft Bearing Set Chocking Using Belzona 7111

ID: 10238

Industry: Marine  
Application: GSS-Gaskets, Seals and Shims  
Substrate: Carbon steel  
Products: Belzona 7111

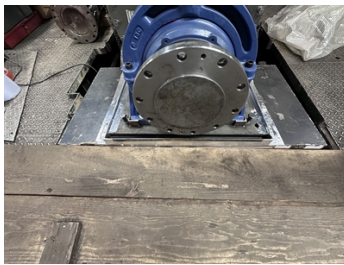
Bearing Foundation Set and Aligned

The carbon steel bearing seat surfaces were prepared using hand tools to remove all surface contaminants, mill scale, and oxidation, establishing a clean substrate suitable for bonding. A 1-inch gap was maintained between the bearing and the foundation to accommodate the Belzona 7111 pour. Dams were constructed around each bearing seat to contain the liquid chocking compound during the pour. Belzona 7111 was mixed and poured in accordance with Belzona's Instructions for Use (IFUs). Four units of material were used per pour, and the installation required four separate pours to complete the full shaft bearing set. Each pour was allowed to cure for one day before proceeding. Release agent was applied to all non-bonding surfaces to ensure clean separation where required.

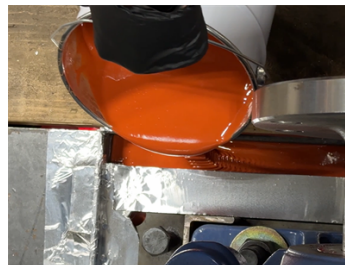
Belzona 7111 Being Poured Into Foundation

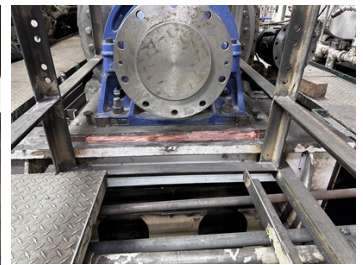
Completed Application

Cost savings were the primary driver for this project. Belzona 7111 delivered a precision chocking solution at a fraction of the cost of traditional machined steel chocks, while providing full-contact load distribution and reliable long-term alignment. The customer was satisfied with the result and would use Belzona again for future chocking applications.
